Wetland and Waterbody Delineation Report

Somerset Solar Project

Town of Somerset, Niagara County, New York

August 9, 2021

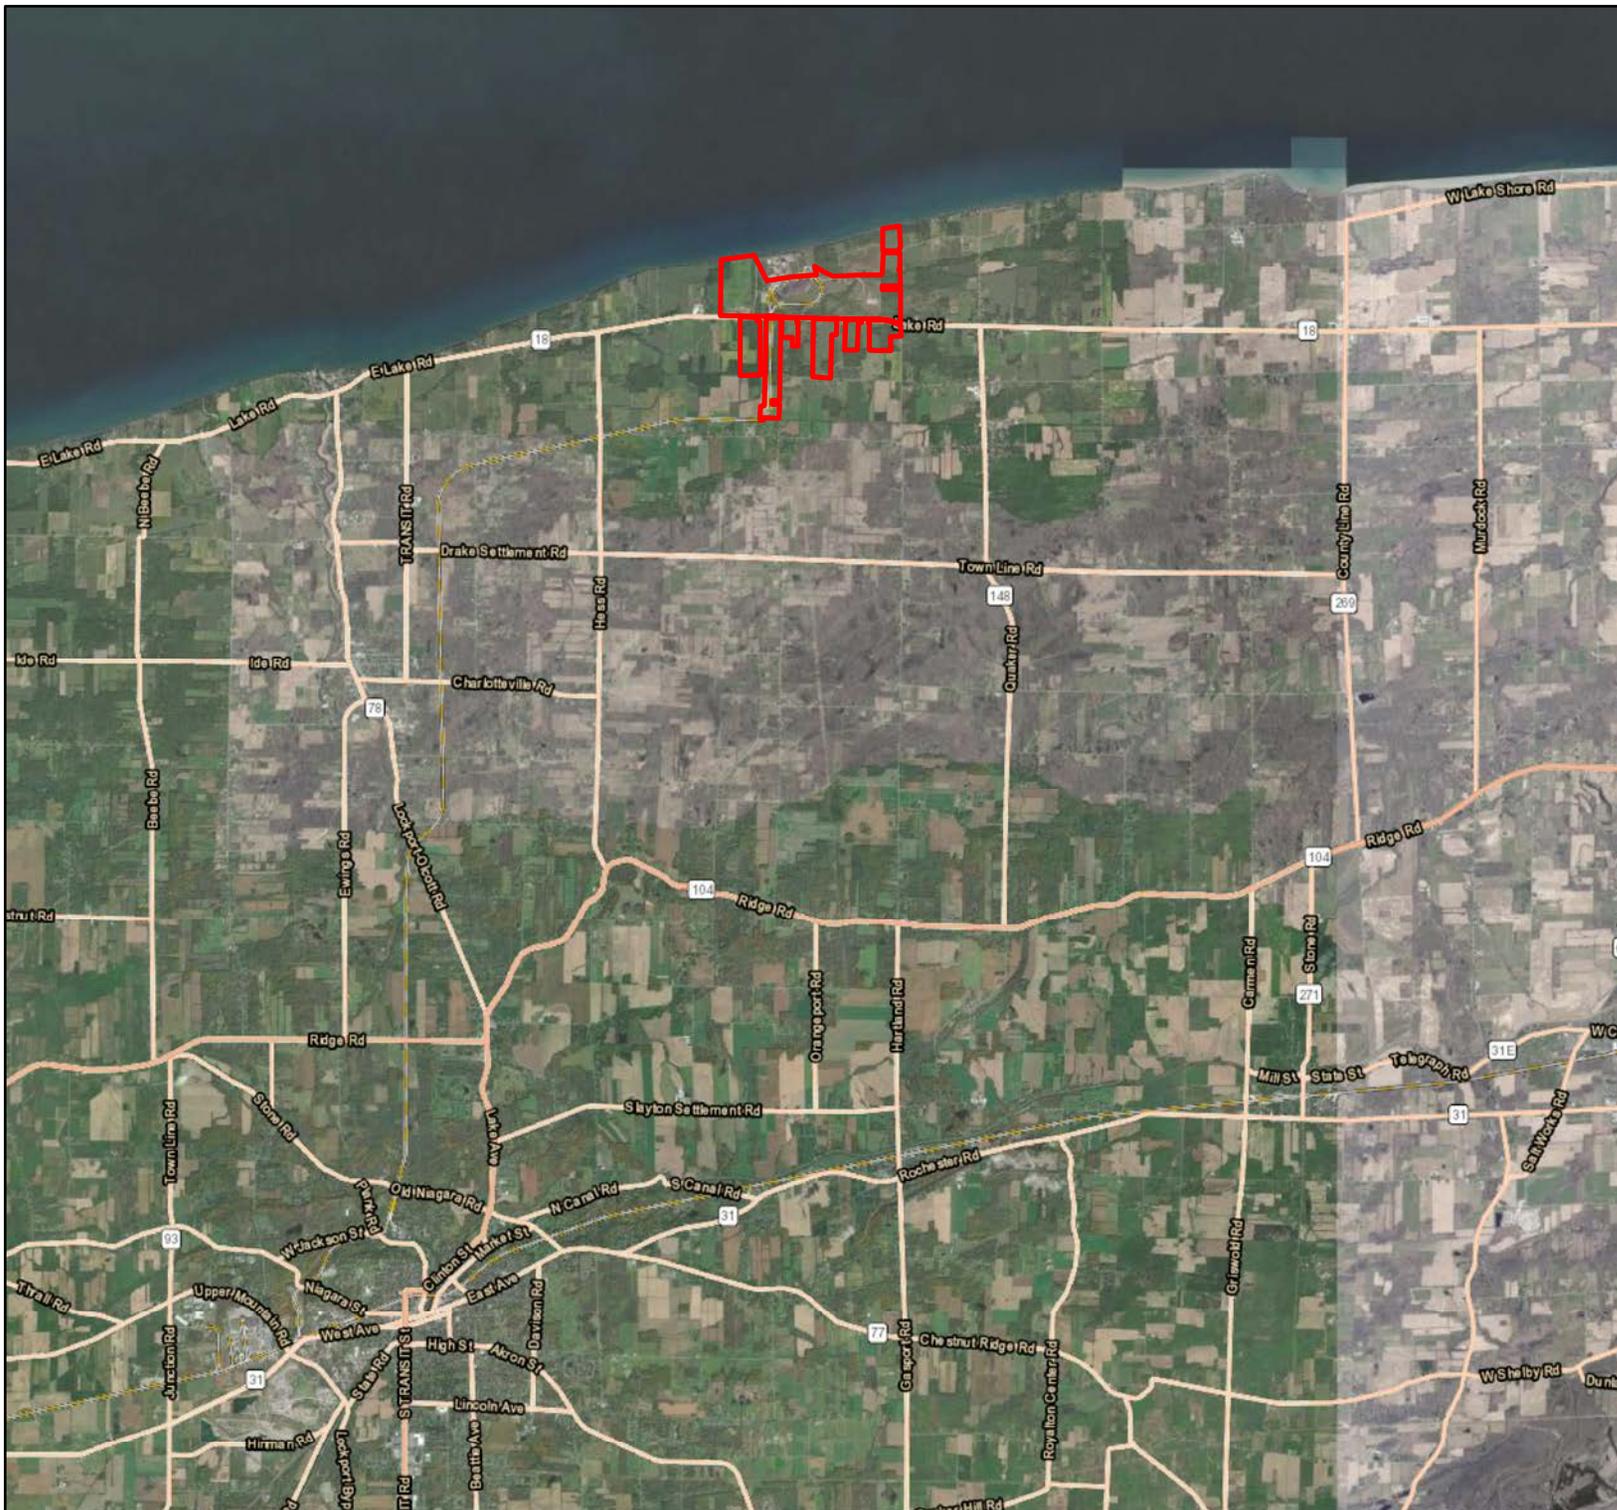
Figure 2
Aerial Map

The Project is located on portions of an inactive coal-fired power plant and adjacent parcels. Within the developed portion of the Project located north of Lake Road, land use consists primarily of open fields, shrubland, and infrastructure including a landfill and railroad. Land cover is a mixture of agricultural fields (row crops) and forested lands (mesic hardwoods) on adjacent parcels. Aerial photography is found in Figure 2.

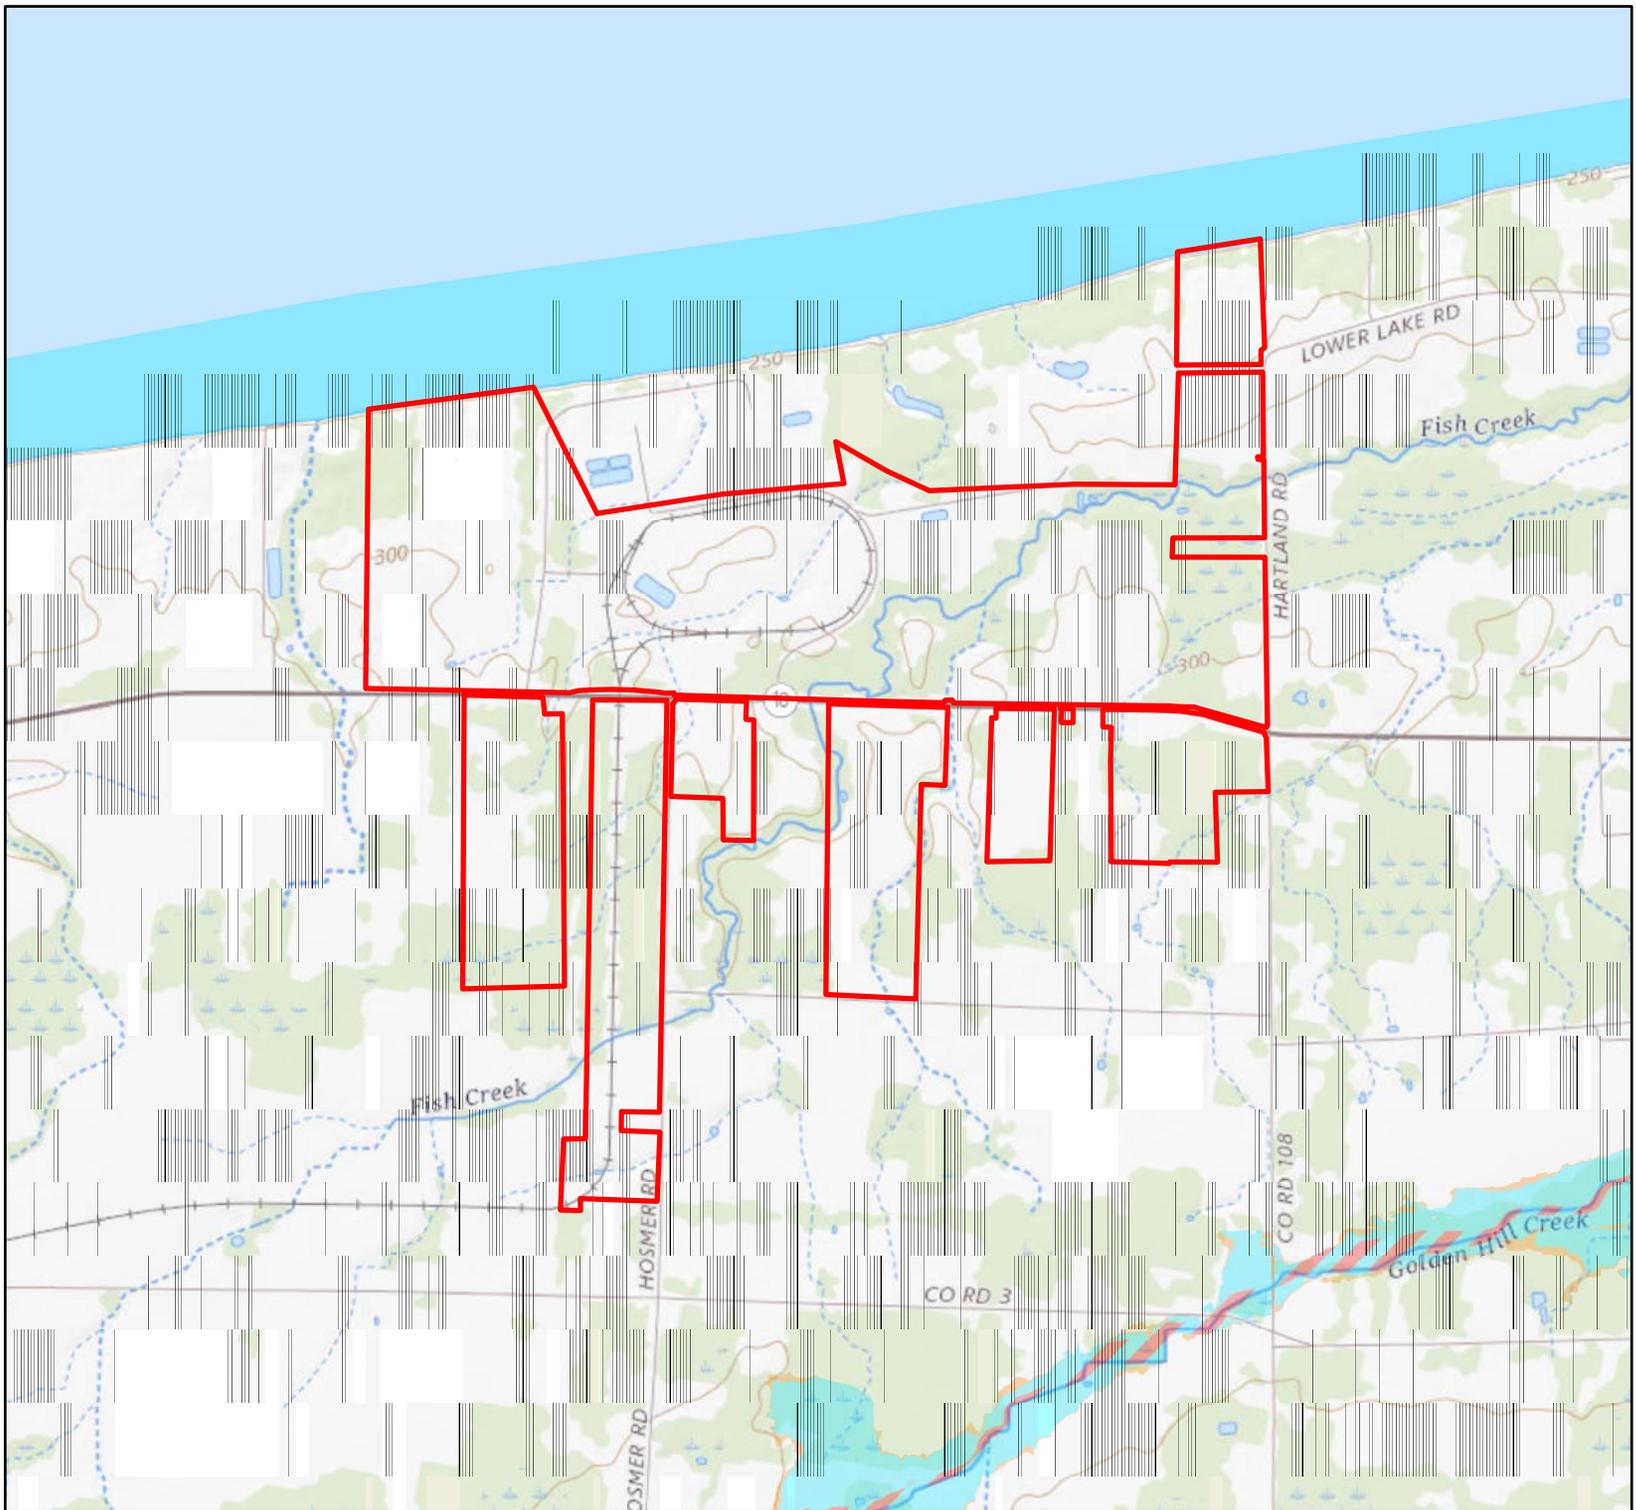
Figure 3
FEMA Flood Hazard Zones

The Project Area contains one named river system, Fish Creek, which enters from the southwest and travels northeast. Fish Creek and other unnamed tributaries within the Project Area drain north into Lake Ontario. According to the Federal Emergency Management Agency (FEMA) National Flood Hazard Layer, the entirety of the Project Area is located within Zone X: *area of minimal flood hazard* (FEMA 2021). A FEMA Flood Map is included as Figure 3.

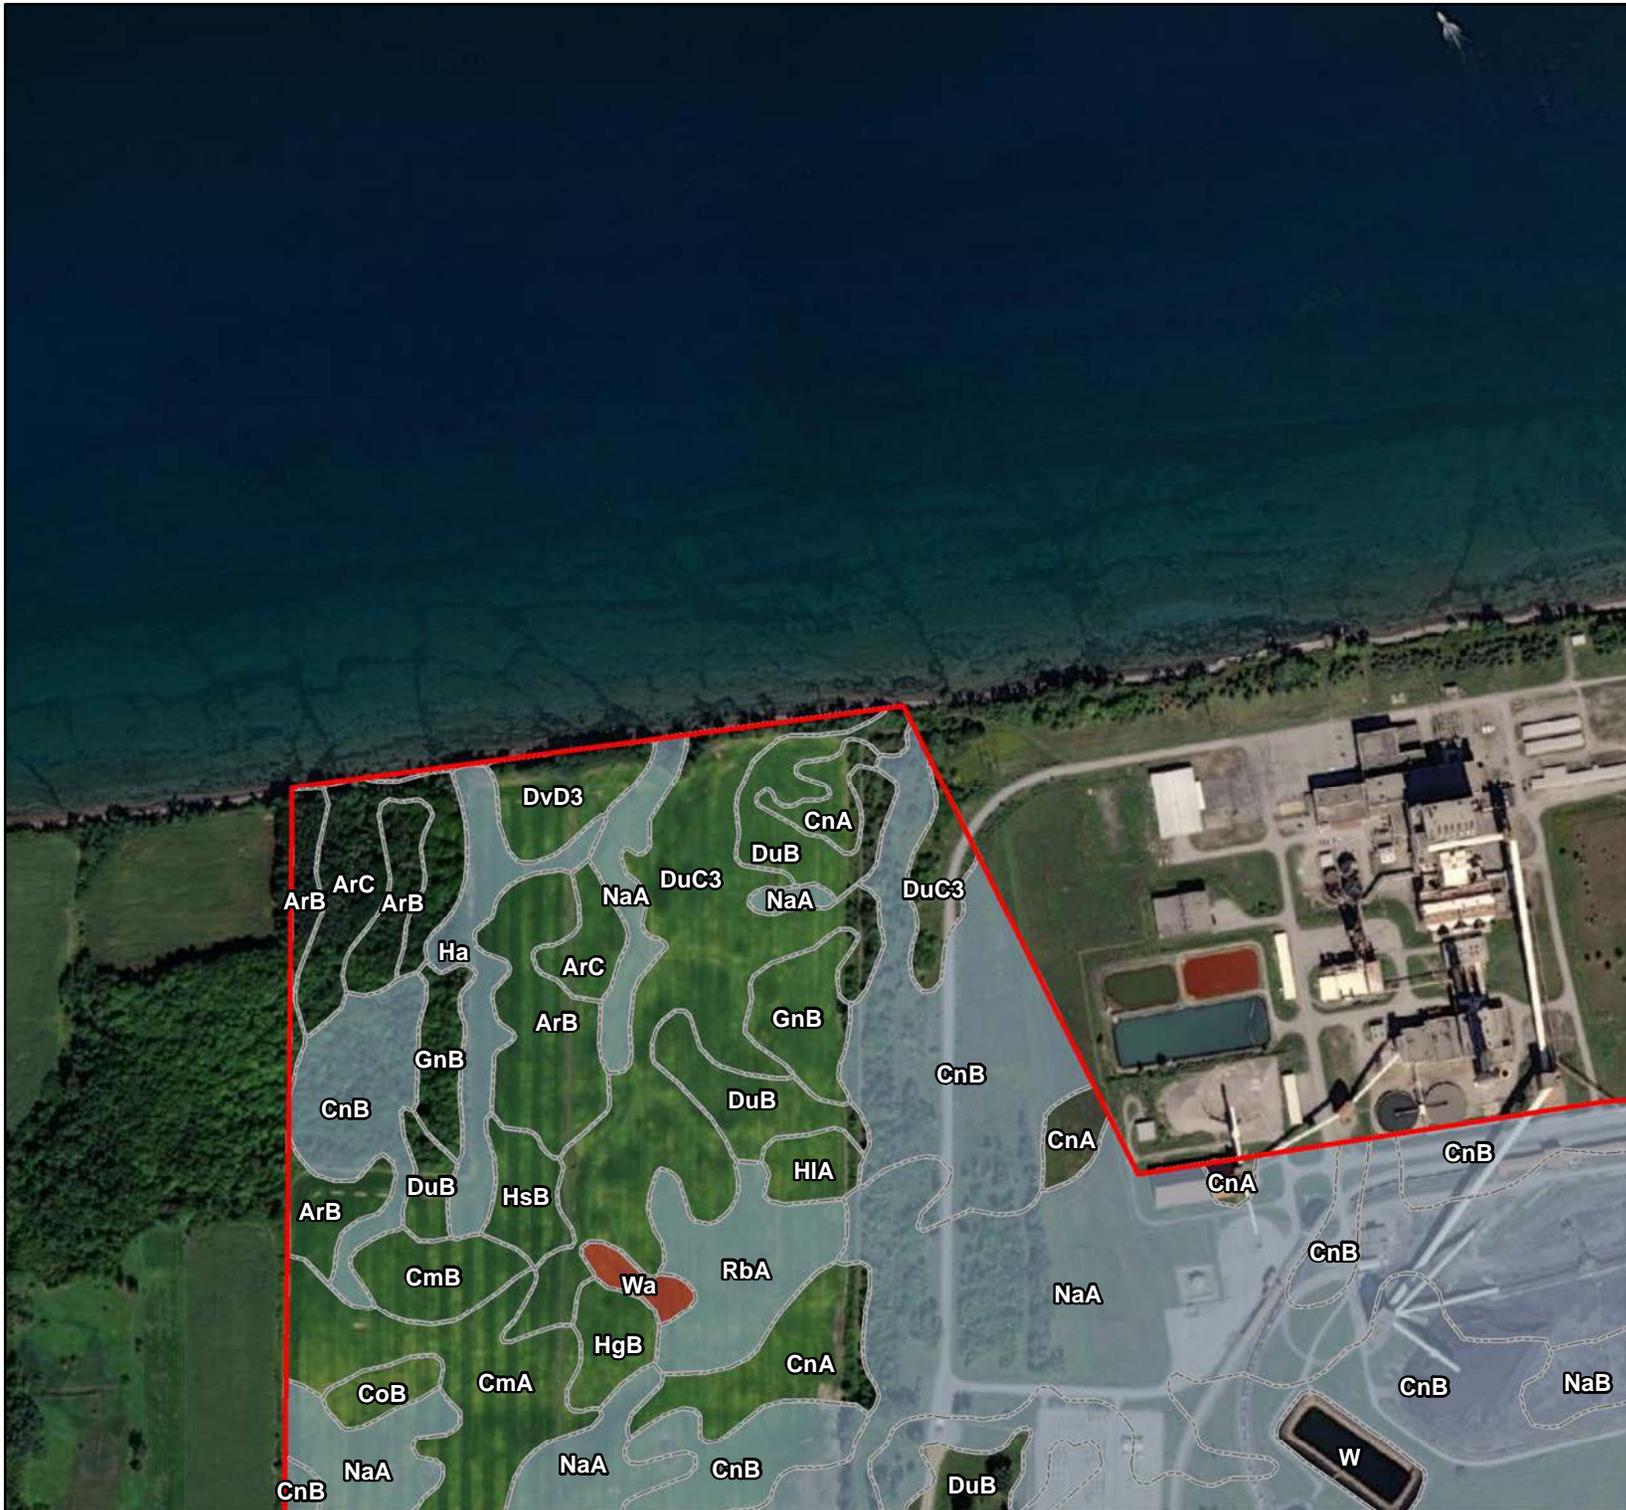
Figure 4-1
NRCS Soil Units and
Hydric Rating Map

The NRCS Web Soil Survey, called Soil Survey Geographic Database (SSRUGO), was used to obtain soil survey information for Niagara County. The information was the most current county soil information available electronically. Existing soils maps were used as a guide to identify locations of potential hydric soils. Field investigation was required to verify the presence of hydric soils, particularly given the disturbed conditions present throughout much of the Project Area. Figure 4 presents the soil series mapped in the Project Area.

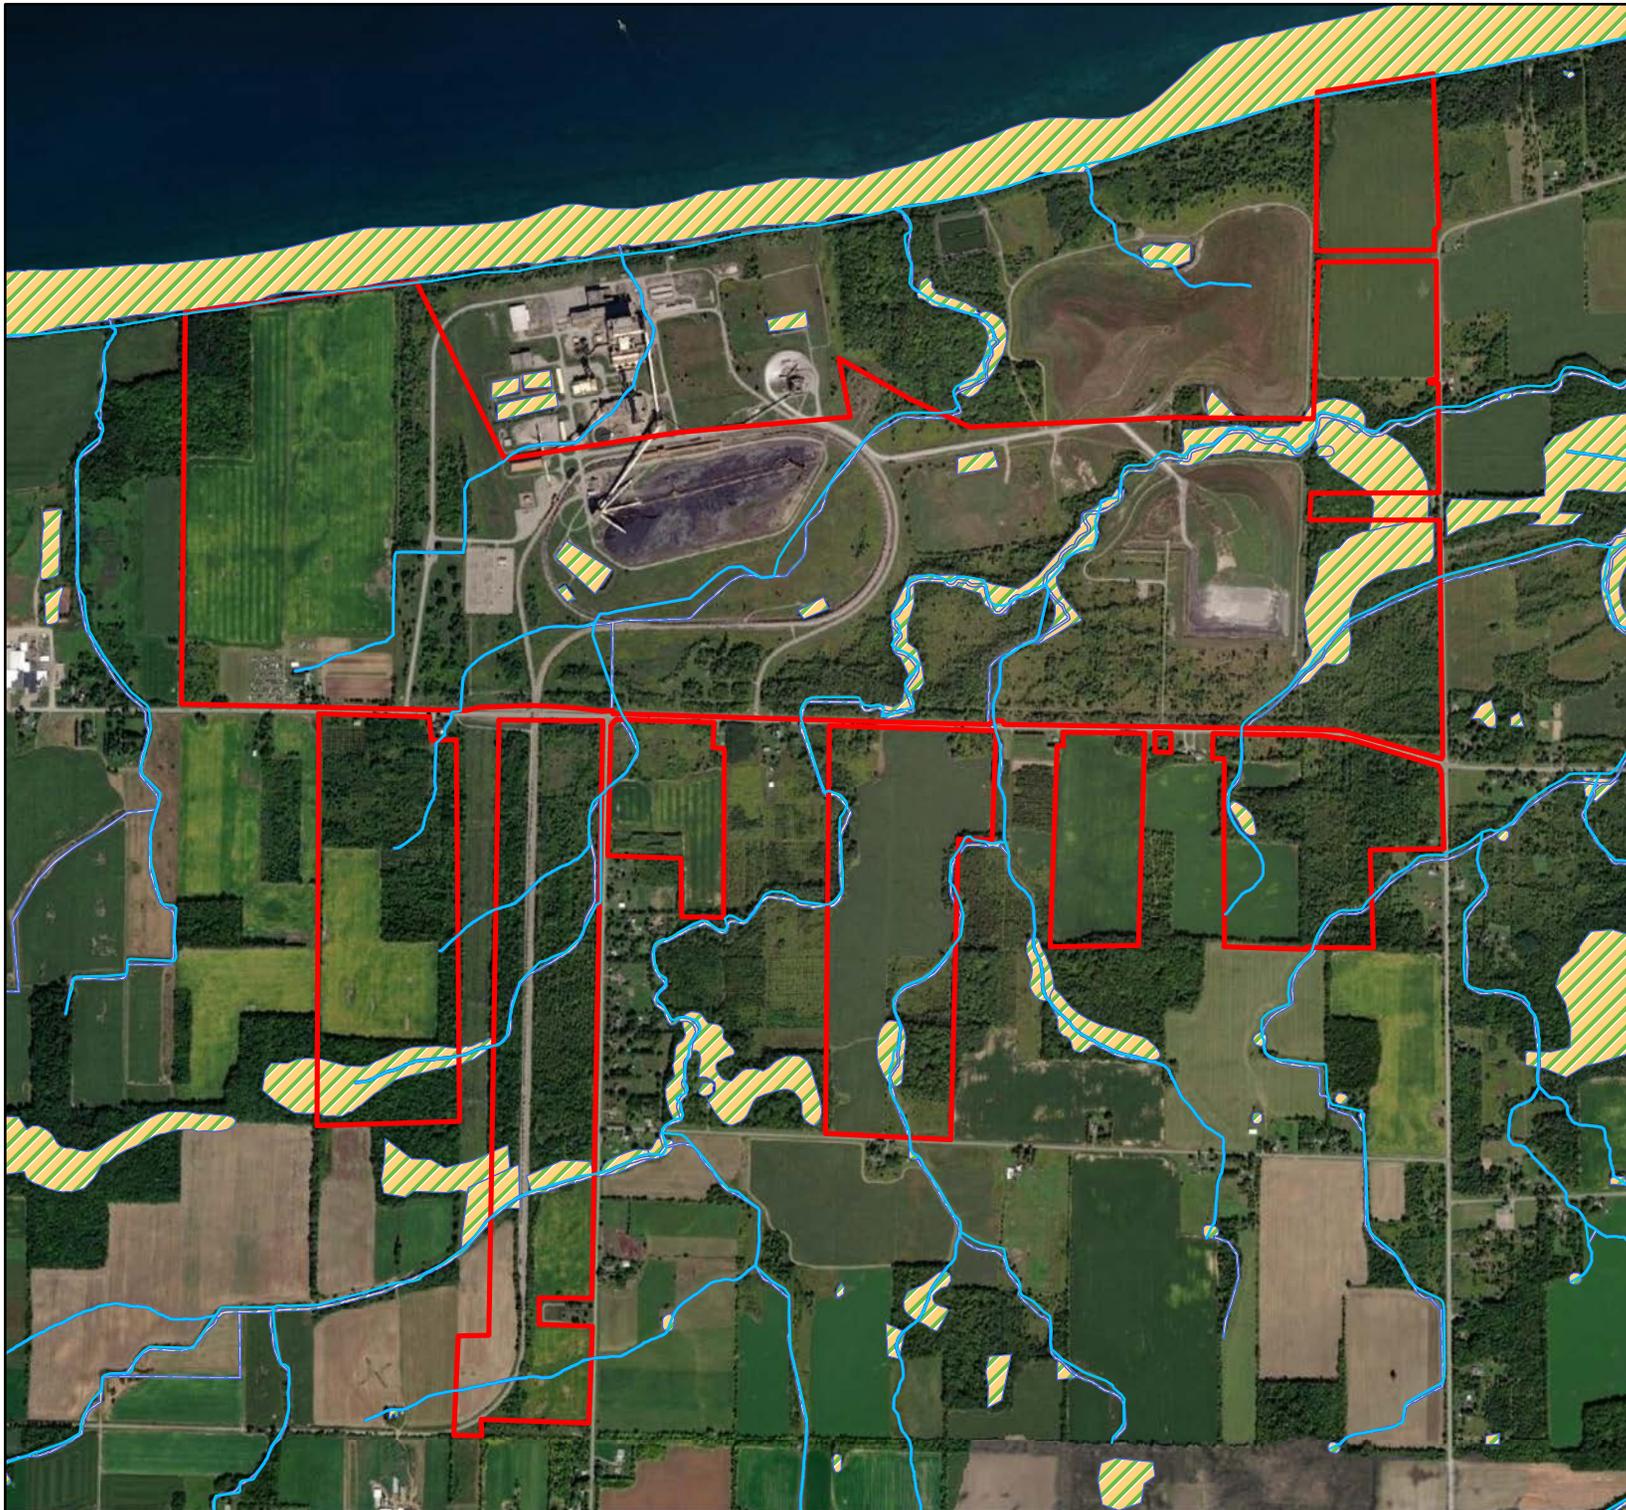
Figure 5
Mapped Aquatic Features

NWI data were overlaid on high-resolution aerial imagery and reviewed in conjunction with soil surveys and topographic maps. Ground conditions are subject to change and because the criteria used to identify wetlands for mapping purposes may have been different than the currently required by the U.S. Army Corps of Engineers (USACE), wetland maps were only used as a guide to aide in identifying potential wetlands. This data was provided to the field crews to guide fieldwork. NWI mapping is included in Figure 5.

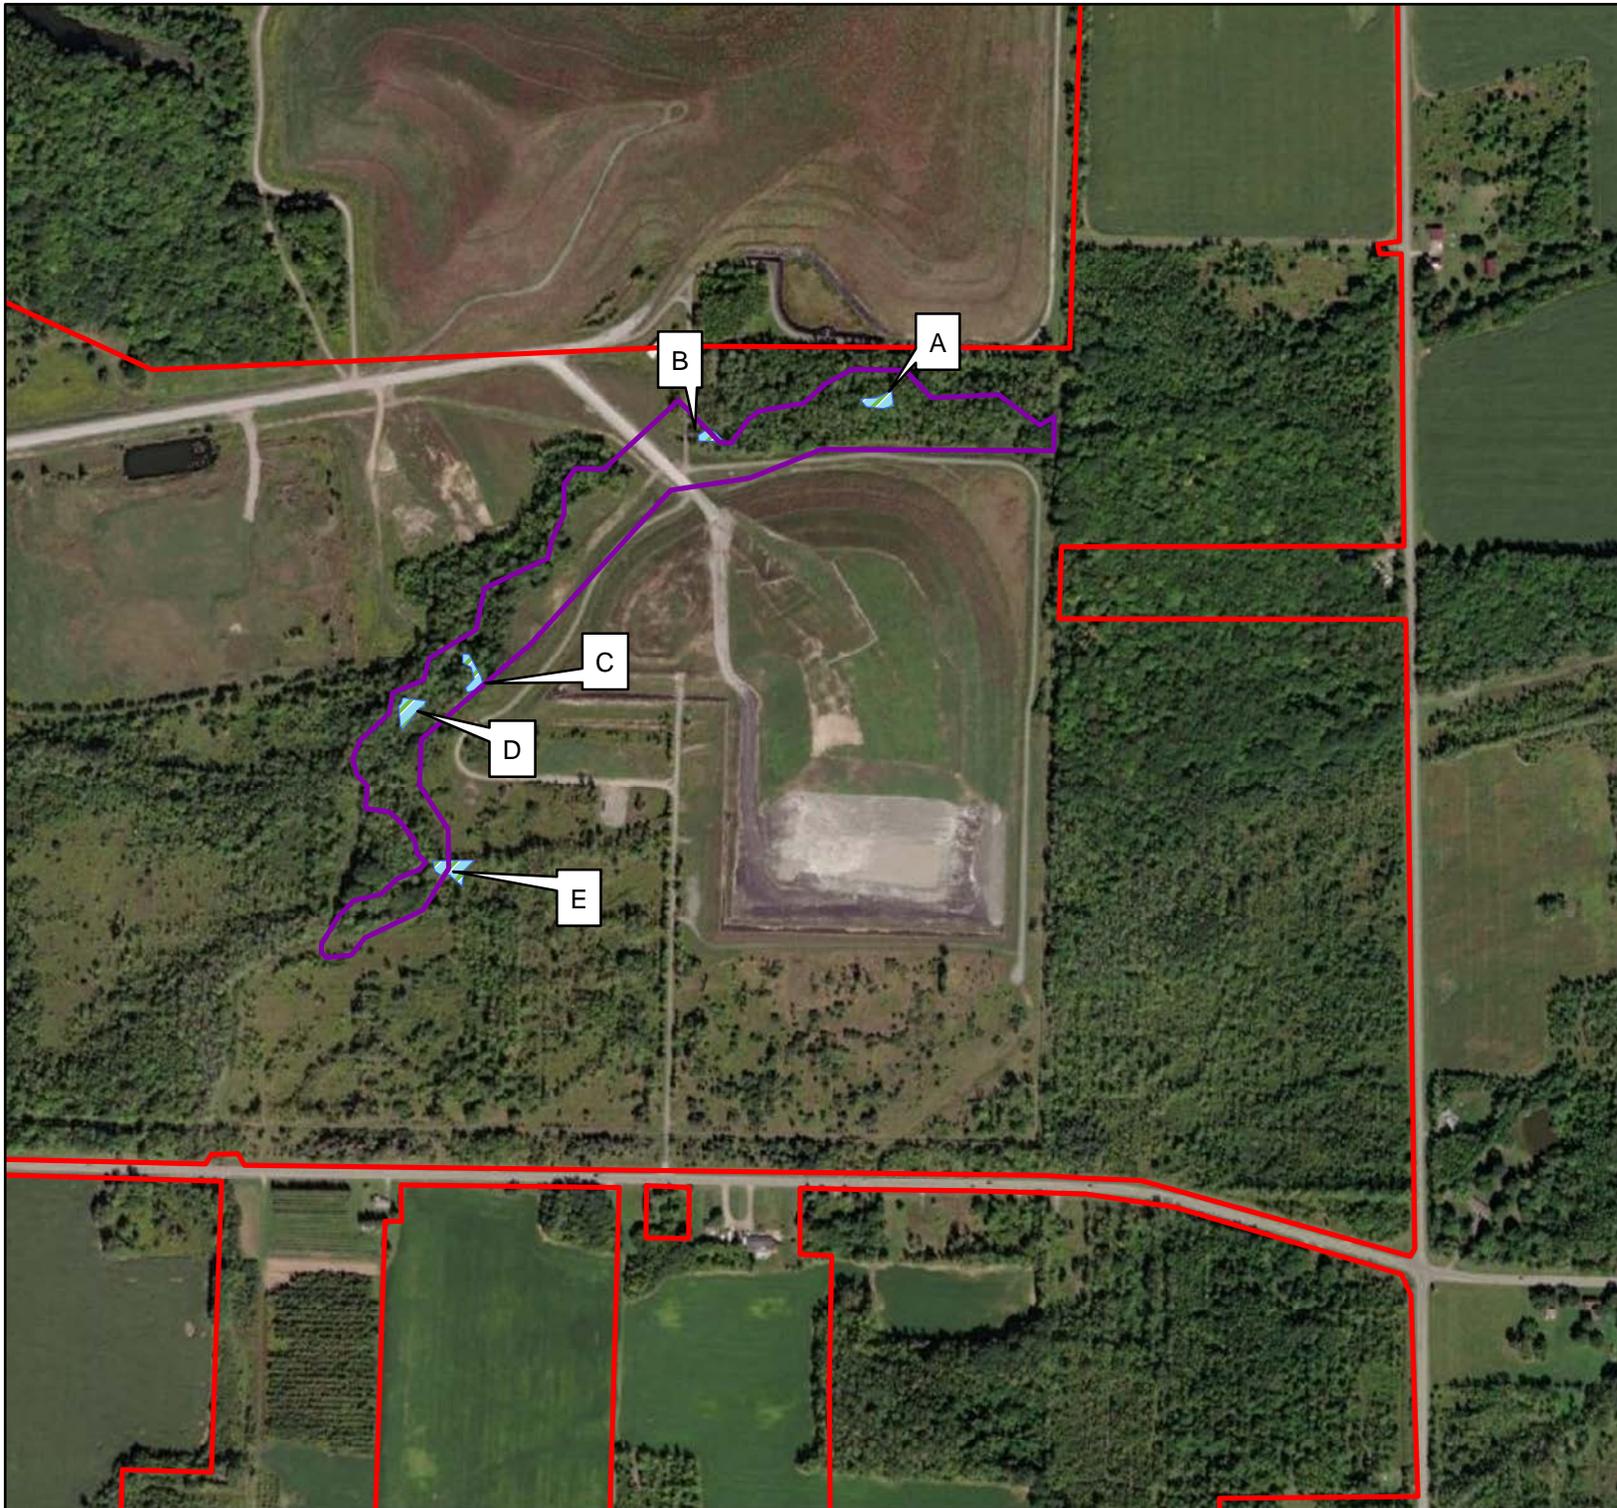
Figure 7
Stantec Wetland Delineation Findings within Study Area

In 2003, Stantec Consulting Services, Inc. of Lancaster, New York conducted a routine wetland delineation for selected locations near Fish Creek and beyond the solid waste disposal areas noted above for AES Somerset LLC. This delineation identified five small wetlands within the survey area with a total wetland area of approximately 0.40 acres. The Stantec wetland delineation map findings associated with the activities completed within the Project Area are included as Figure 7.

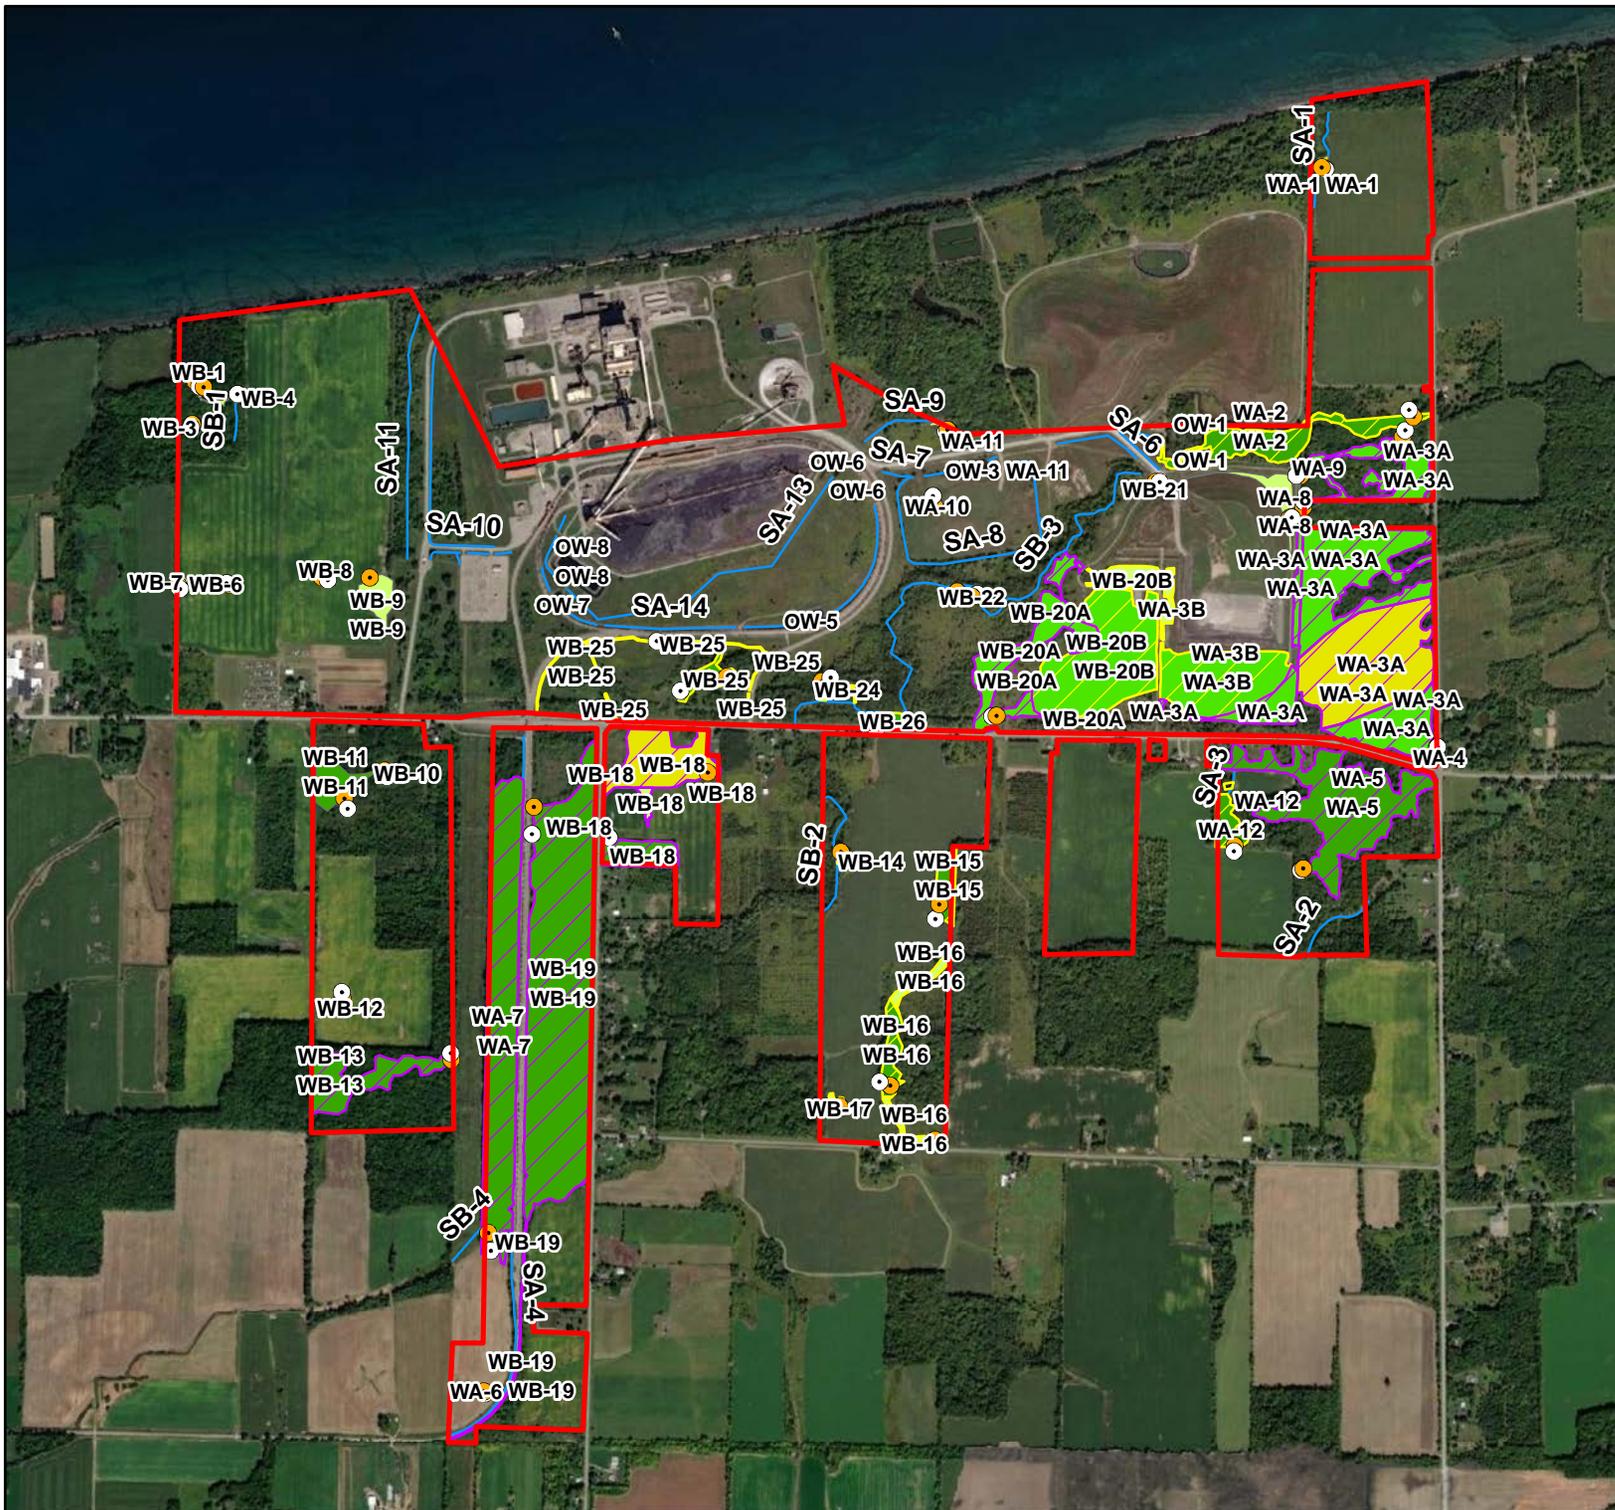
Figure 8 Overview
Delineated Aquatic Features

Tetra Tech identified 40 wetlands (267.43 acres) within the Project Area (Figure 8). Data sheets can be found in Appendix B, and photographs are provided in Appendix C. Table 3 summarizes the delineated wetlands and brief descriptions are provided below. There are no mapped NYSDEC regulated freshwater wetlands in the Project Area or adjacent properties. The closest state mapped wetlands are approximately 1.4 miles southeast (ID: BA-21 and BA-22, Class 3) and have low potential hydrologic connectivity to onsite wetlands.

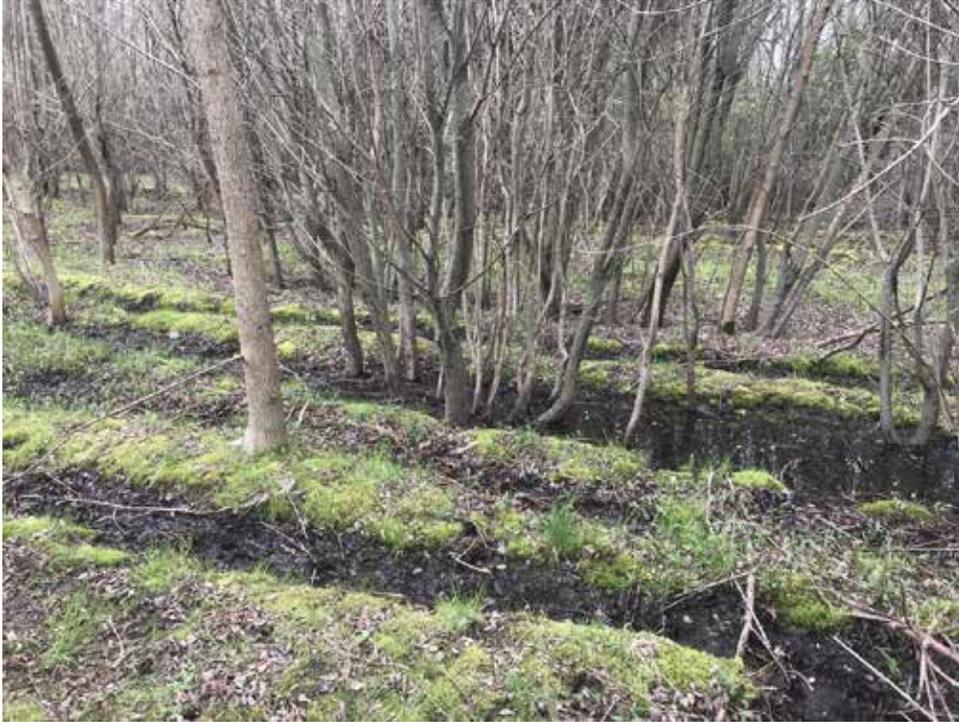
Wetland WA-1 – Wetland WA-1 was an inundated area of stream SA-1 located in the northeastern portion of the Project Area, adjacent to an area currently used for growing corn. It was located entirely within the Project Area and was 0.3 acres in size. The source of wetland hydrology appeared mostly to be collected runoff from surrounding fields. Dominant vegetation was pussy willow (*Salix discolor*). Hydric soil conditions met the requirements of a depleted matrix starting at 0 inches and continued throughout before hitting refusal at 8 inches. This wetland was isolated with no apparent hydrologic connection to a Water of the U.S. (WOTUS); therefore it should not be afforded jurisdiction from the USACE. Wetland WA-1 was less than 12.4 acres in size and was not the current boundary of a mapped NYSDEC Freshwater Wetland, therefore it should not be under jurisdiction of the State.

Photograph 1 – Wetland WA-1
Facing west southwest.
[Taken by Jessica Atutubo on May 3, 2021]

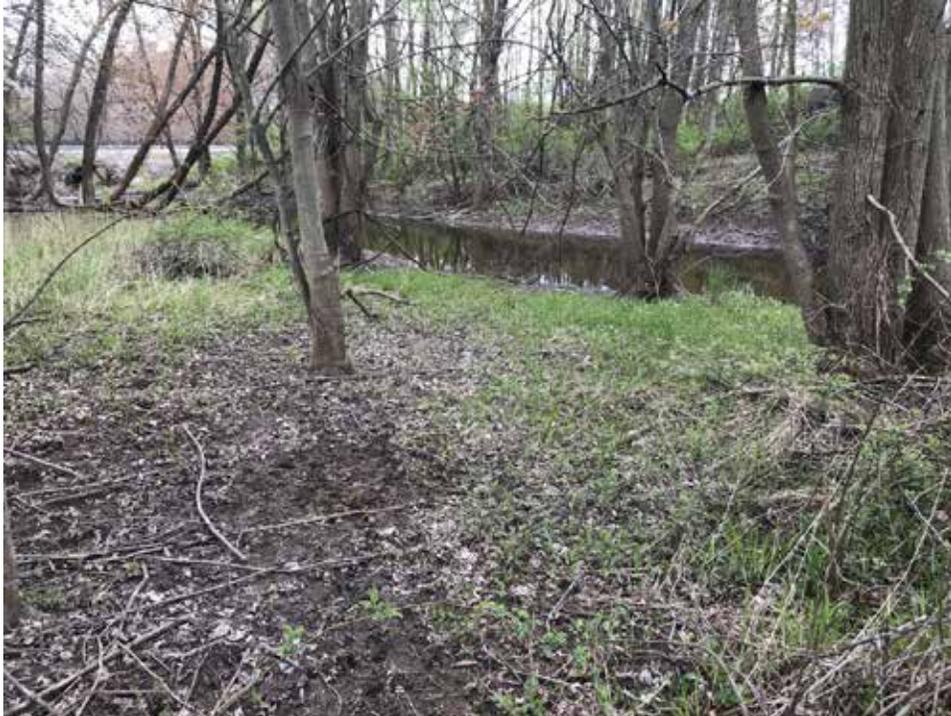
Wetland WA-2 – Wetland WA-2 was 8.62 acres in size, located within the eastern portion of the Project Area. The source of wetland hydrology was primarily Fish Creek, which ran through the wetland, and surface runoff. Dominant vegetation included green ash, eastern cottonwood in the tree layer, silky dogwood in the shrub layer, and reed canary grass, sensitive fern (*Onoclea sensibilis*) and jewelweed (*Impatiens capensis*) in the herb layer. Hydric soil conditions met the requirements of a depleted matrix starting at 8 inches and continued for 20 inches. Please note that this wetland area is significantly larger than previously delineated in 2003 and that the hydric soil conditions has changed in the past 18 years.

Photograph 2 – Wetland WA-2
View of wetland on fringe of Fish Creek. Facing east southeast.
[Taken by Jessica Atutubo on May 5, 2021]

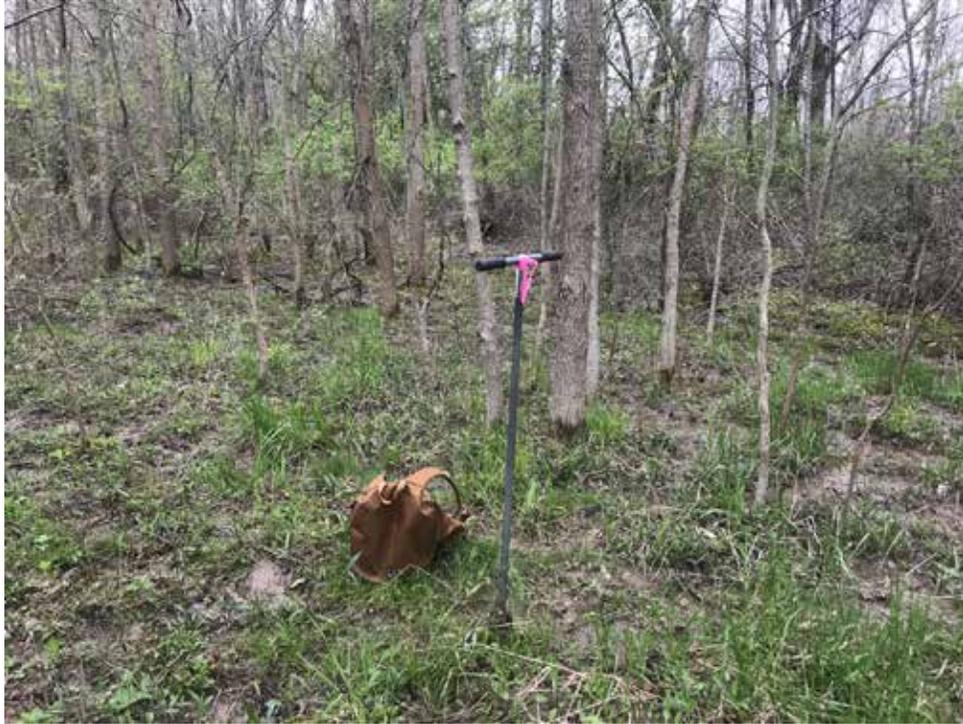
Wetland WA-3A – Wetland WA-3A was 63.18 acres in size, located within the eastern portion of the Project Area. It was composed of several habitat types including forested swamps, successional shrub swamp, and emergent wetlands. The source of wetland hydrology was primarily surface runoff. Dominant vegetation included green ash, eastern cottonwood in the tree layer, silky dogwood and grey dogwood (*Cornus racemosa*) in the shrub layer, and reed canary grass in the herb layer. Hydric soil conditions met the requirements of a depleted matrix starting at 10 inches and continued for 20 inches. Wetland WA-3A was classified as USACE-jurisdictional due to having a hydrological connection to a WOTUS, Fish Creek. WA-3A was classified as State jurisdictional as it was over 12.4 acres in size.

Photograph 3 – Wetland WA-3
Facing west northwest.
[Taken by Jessica Atutubo on May 3, 2021]

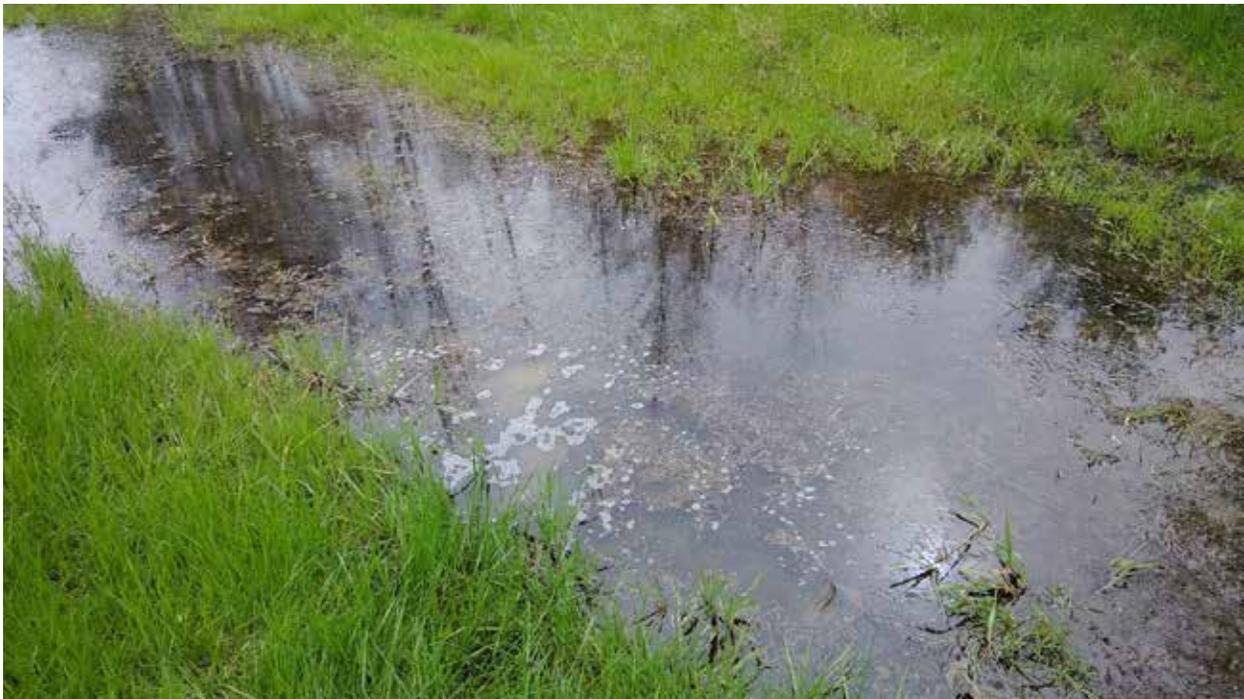
Wetland WA-4 – Wetland WA-4 was 0.01 acres in size, located within the eastern portion of the Project Area by Hartland Road. It was a small drainage collection that was sourced primarily by surface runoff. The dominant vegetation was fowl manna grass (*Glyceria striata*). Hydric soil conditions met the requirements of a depleted matrix starting at 3 inches and continued throughout to 8 inches. This wetland was isolated with no apparent hydrologic connection to a WOTUS and therefore it should not be afforded jurisdiction from USACE. Since it was less than 12.4 acres in size and was not the current boundary of a mapped NYSDEC Freshwater Wetland, it should not be under State jurisdiction.

Photograph 4 – Wetland WA-4
[Taken by Drew Timmis on May 4, 2021]

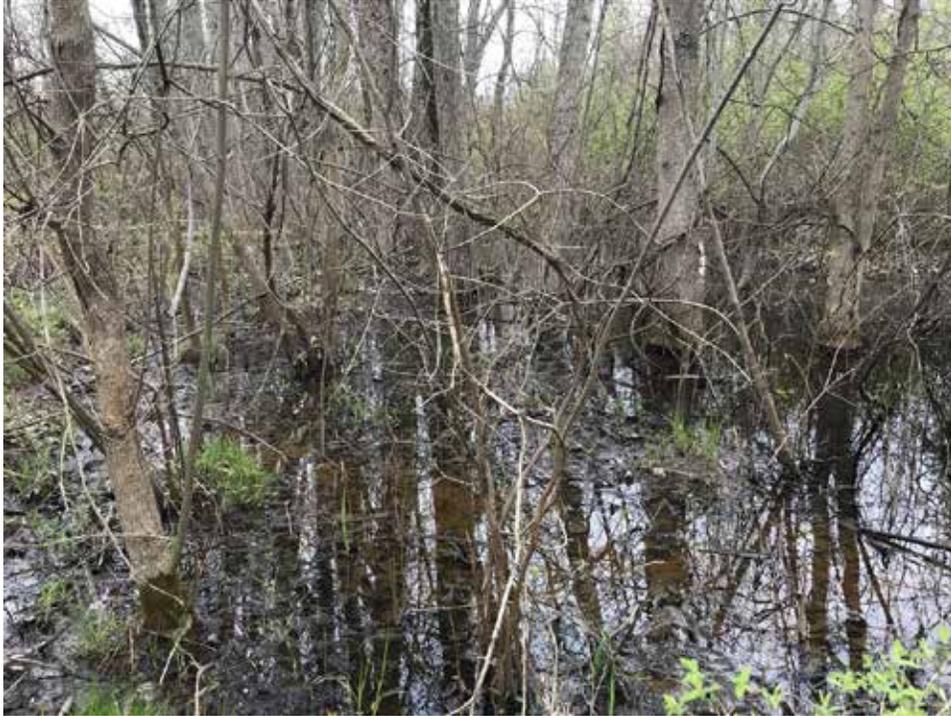
Wetland WA-5 – Wetland WA-5 was 22.23 acres in size, located within the eastern portion of the Project Area. The source of hydrology was primarily surface runoff. Dominant vegetation included green ash, eastern cottonwood, and red maple. Hydric soil conditions met the requirements of a depleted matrix starting at 0 inches and continued for 20 inches and a hydrogen sulfide odor present. This wetland was classified as USACE-jurisdictional due to having a hydrological connection to a WOTUS (an unnamed tributary to Fish Creek) and classified as State-jurisdictional as it was over 12.4 acres in size.

Photograph 5 – Wetland WA-5
Facing southwest.
[Taken by Jessica Atutubo on May 5, 2021]

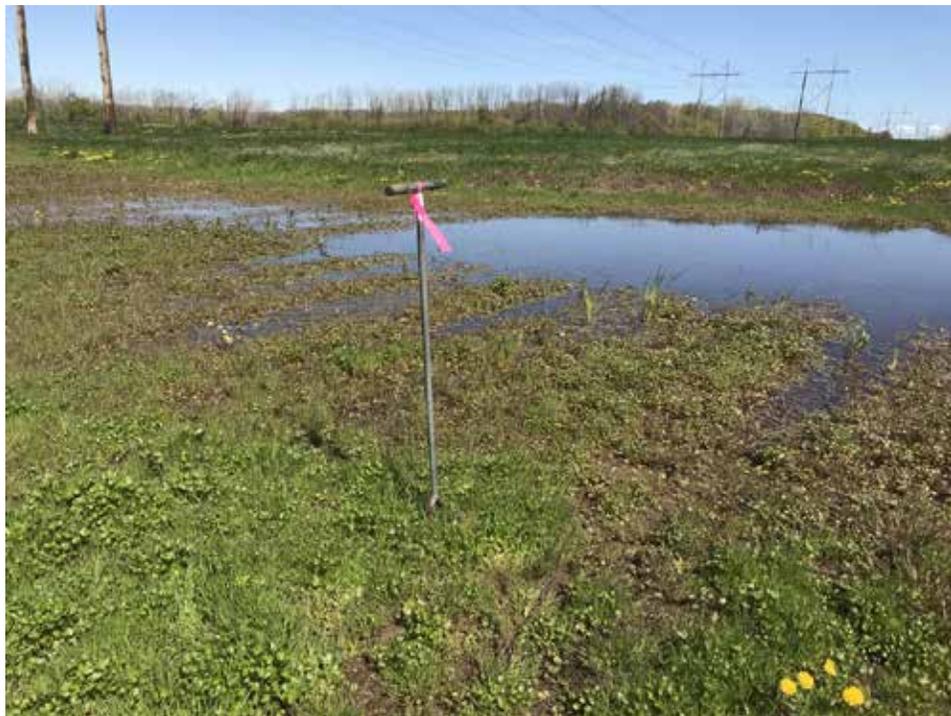
Wetland WA-6 – Wetland WA-6 was 0.51 acres in size, located within an open field in the southern portion of the Project Area. The source of hydrology was primarily surface runoff. Dominant vegetation included celery-leaved buttercup (*Ranunculus sceleratus*) and yellow rocketgrass (*Barbarea vulgaris*). Hydric soil conditions met the requirements of a depleted matrix starting at 0 inches and continued for 16 inches. This wetland was isolated with no apparent hydrologic connection to a WOTUS and therefore it should not be afforded jurisdiction from USACE. Since it was less than 12.4 acres in size and was not the current boundary of a mapped NYSDEC Freshwater Wetland, it should not be under State jurisdiction.

Photograph 6 – Wetland WA-6
Facing northwest.
[Taken by Jessica Atutubo on May 10, 2021]

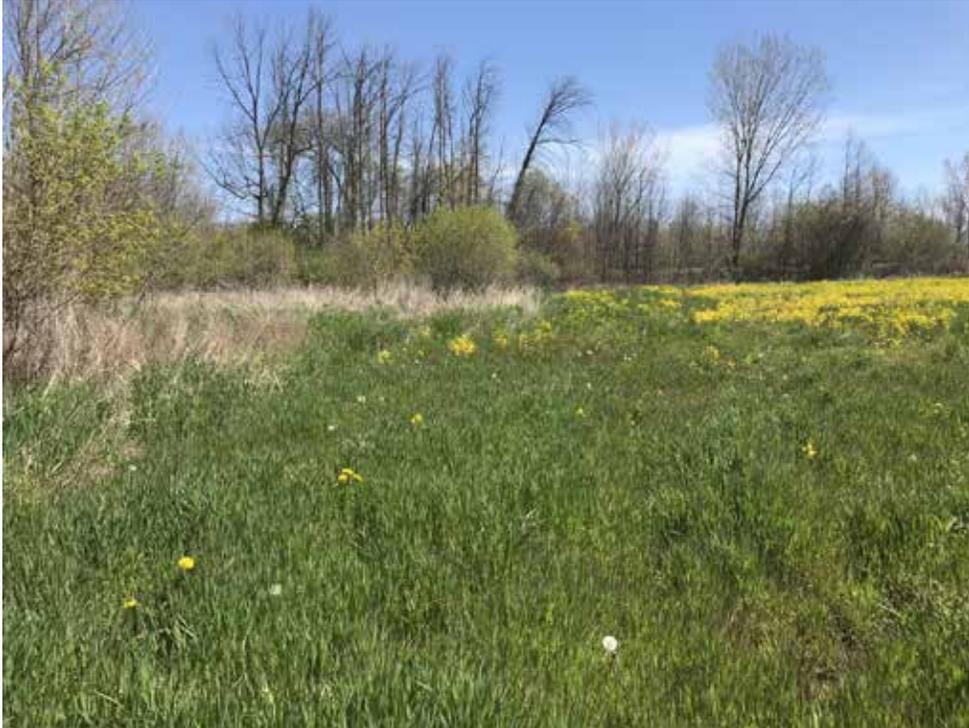
Photograph 7 – Wetland WA-7
Showing cover type change from wet meadow to shrub. Facing northeast.
[Taken by Jessica Atutubo on May 10, 2021]

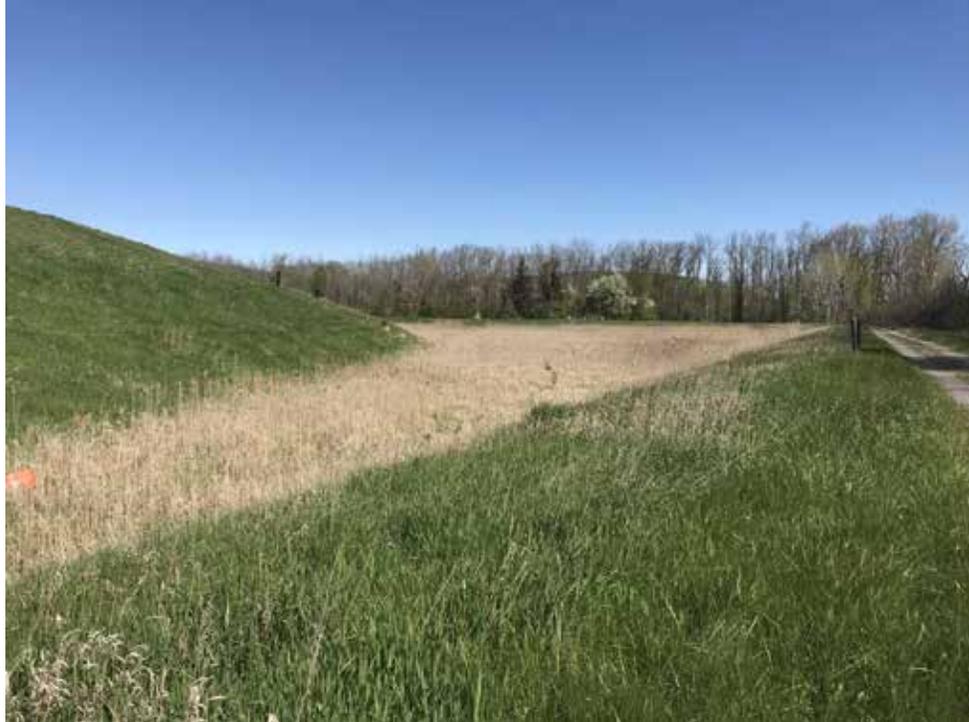
Wetland WA-8 – Wetland WA-8 was a 2.33-acre vegetated stormwater sedimentation basin that was designed pursuant to the existing license with the NYSDPS. The engineered drainage basin is located next to the active solid waste disposal area (SWDA-2) located within the Project Area. During the time of the survey water levels were low allowing for the propagation of hydrophytic vegetation. The source of wetland hydrology was primarily surface runoff. Dominant vegetation included common reed and reed canary grass. Hydric soil conditions met the requirements of a depleted matrix starting at 0 inches

Photograph 8 – Wetland WA-8
Facing north northwest.
[Taken by Jessica Atutubo on May 11, 2021]
