Wetland and Waterbody Delineation Report

Somerset Solar Project

Town of Somerset, Niagara County, New York

August 9, 2021

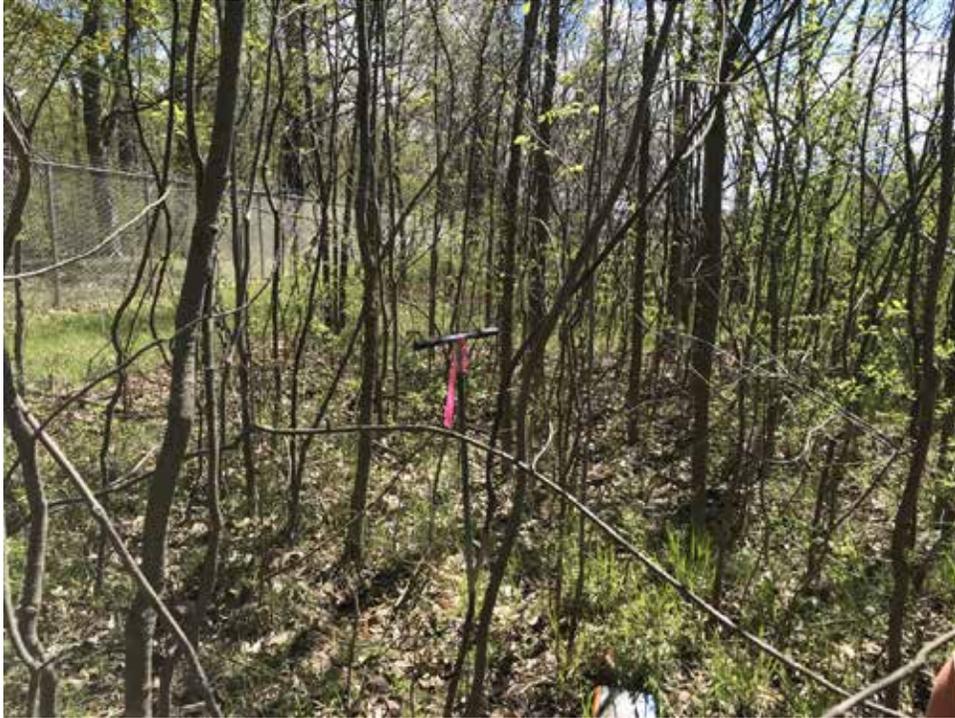
Wetland WA-9 – Wetland WA-9 was 0.21 acres in size, located in the eastern portion of the Project Area. The source of wetland hydrology was primarily from surface runoff. Dominant vegetation included American elm, eastern cottonwood, and pussy willow. Hydric soil conditions met the requirements of a depleted matrix starting at 4 inches and continued for 20 inches. This wetland was isolated with no apparent hydrologic connection to a WOTUS and therefore it should not be afforded jurisdiction from USACE. Since it was less than 12.4 acres in size and was not the current boundary of a mapped NYSDEC Freshwater Wetland, it should not be under State jurisdiction.

Photograph 9 – Wetland WA-9
Facing south.
[Taken by Jessica Atutubo on May 11, 2021]

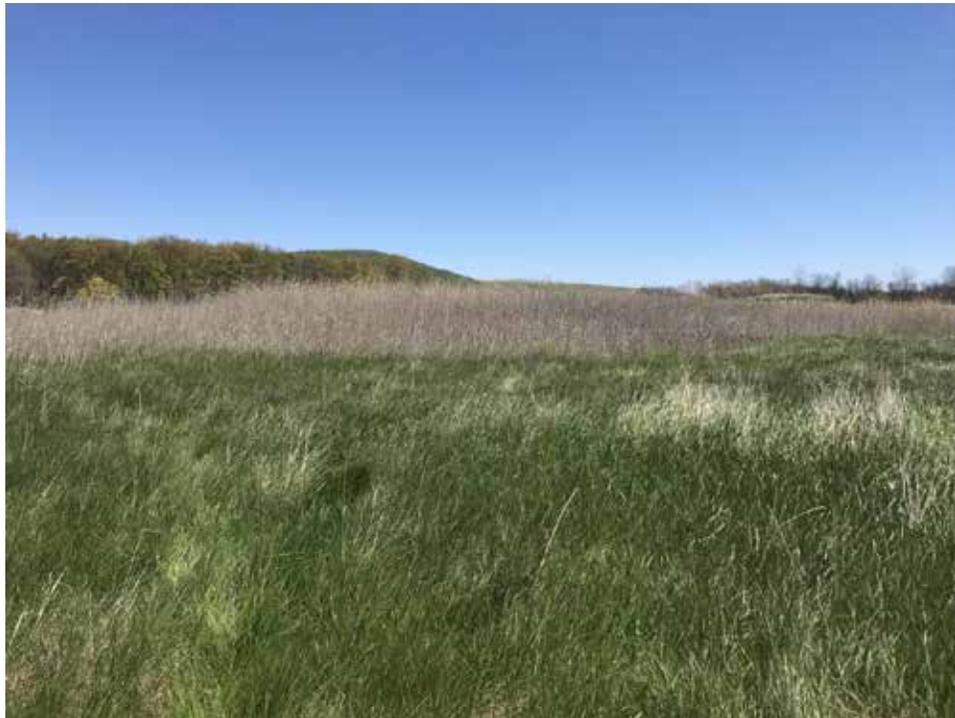
Wetland WA-10 – Wetland WA-10 was 0.44 acres in size, located in the eastern portion of the Project Area and within SWDA-3. The source of wetland hydrology was primarily from surface runoff. Dominant vegetation included common reed. Hydric soil conditions met the requirements of a depleted matrix starting at 0 inches and continued for 20 inches. This wetland was isolated with no apparent hydrologic connection to a WOTUS and therefore it should not be afforded jurisdiction from USACE. Since it was less than 12.4 acres in size and was not the current boundary of a mapped NYSDEC Freshwater Wetland, it should not be under State jurisdiction.

Photograph 10 – Wetland WA-10
Facing northeast.
[Taken by Jessica Atutubo on May 12, 2021]

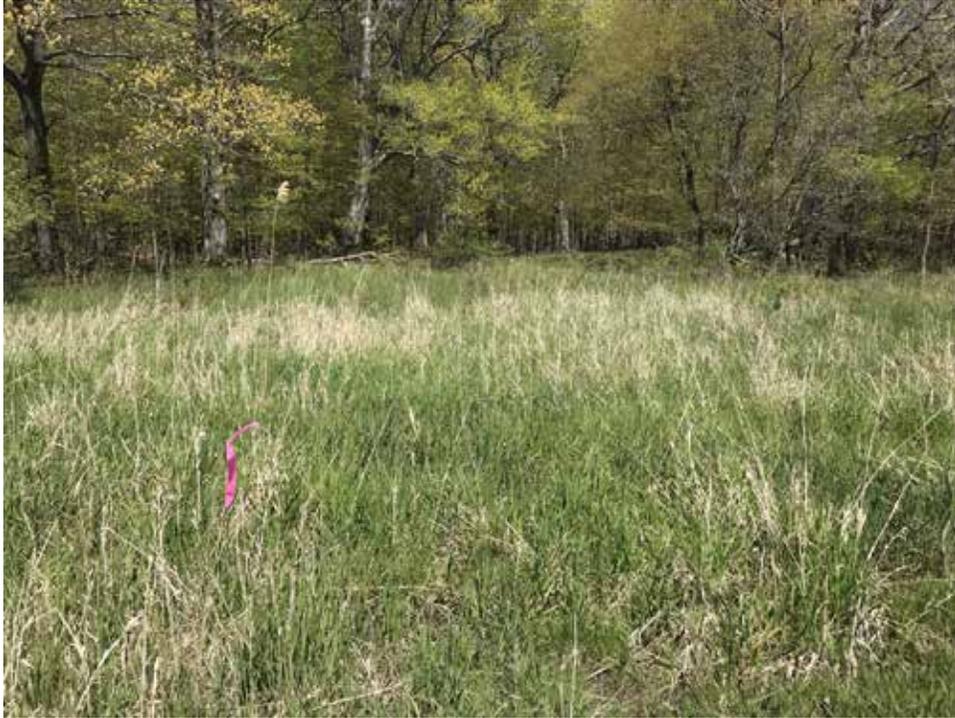
Wetland WA-11 – Wetland WA-11 was 0.58 acres in size, located in the eastern portion of the Project Area within a depressional area adjacent to undeveloped forest and paved access road. The source of wetland hydrology was primarily from surface runoff. Dominant vegetation included reed canary grass and common reed. Hydric soil conditions met the requirements of a thin dark surface from 0 to 5 inches, and a depleted matrix starting at 5 inches and continued for 20 inches. This wetland was isolated with no apparent hydrologic connection to a WOTUS and therefore it should not be afforded jurisdiction from USACE. Since it was less than 12.4 acres in size and was not the current boundary of a mapped NYSDEC Freshwater Wetland, it should not be under State jurisdiction.

Photograph 11 – Wetland WA-11
Facing northeast.
[Taken by Jessica Atutubo on May 12, 2021]

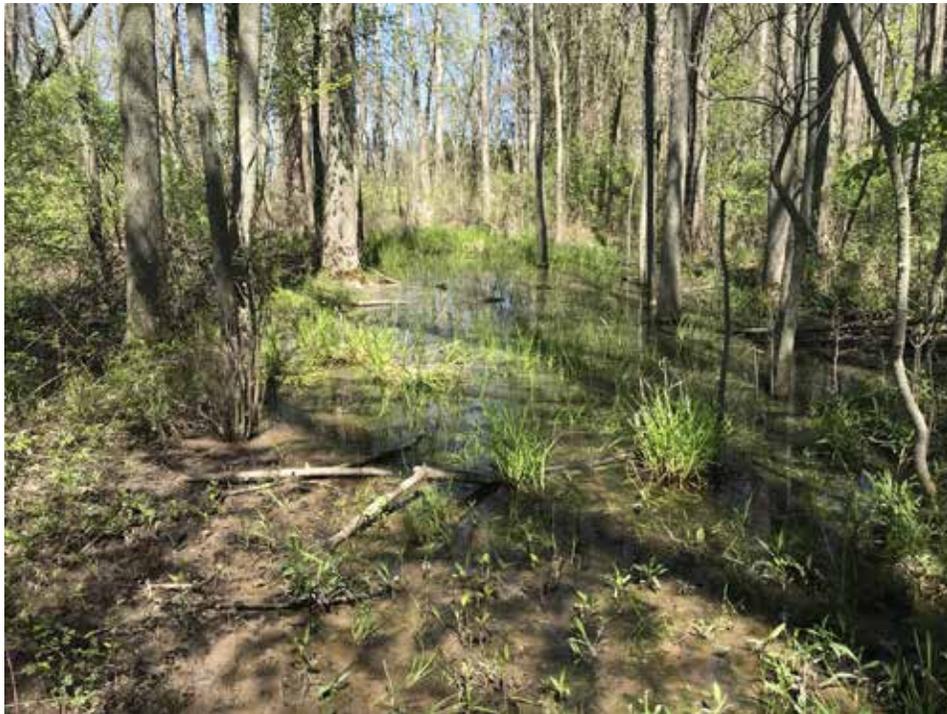
Wetland WA-12 – Wetland WA-12 was 2.33 acres in size, located in the eastern portion of the Project Area within a depressional area within a forested area. The source of wetland hydrology was primarily from surface runoff and ephemeral stream drainage. Stream SA-6 was connected to the northern portion of the wetland. Dominant vegetation included American elm, silver maple, and green ash. Hydric soil conditions met the requirements of a depleted matrix starting at 0 inches and continued for 20 inches. This wetland was classified as USACE-jurisdictional due to having a hydrological connection to a WOTUS, an unnamed tributary. Since it was less than 12.4 acres in size and was not the current boundary of a mapped NYSDEC Freshwater Wetland, it should not be under State jurisdiction.

Photograph 12 – Wetland WA-12
Facing north.
[Taken by Jessica Atutubo on May 13, 2021]

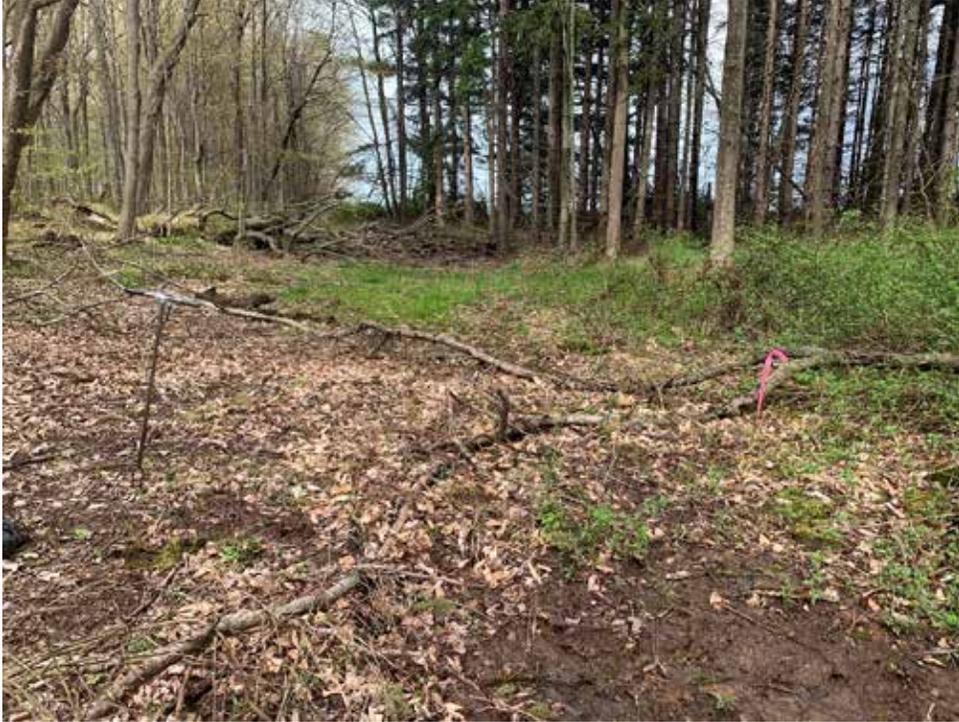
Wetland WB-1 – Wetland WB-1 was 0.01 acres in size, located within a depression in an undeveloped forest patch in the northwestern corner of the Project Area. The source of wetland hydrology was primarily surface runoff. Dominant herbaceous vegetation included box elder and small-flowered agrimony (*Agrimonia parviflora*). Hydric soil conditions met the requirements of a depleted matrix starting at 0 inches and continued for 16 inches. This wetland was isolated with no apparent hydrologic connection to a WOTUS and therefore it should not be afforded jurisdiction from USACE. Since it was less than 12.4 acres in size and was not the current boundary of a mapped NYSDEC Freshwater Wetland, it should not be under State jurisdiction.

Photograph 13 – Wetland WB-1
Facing west.
[Taken by Tony Cimpi on May 3, 2021]

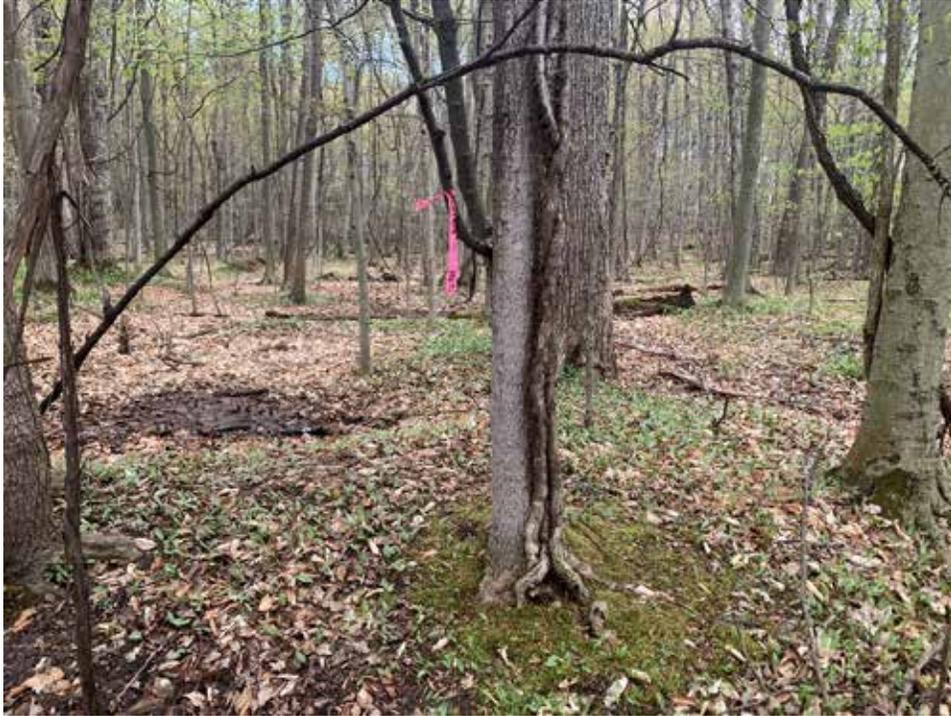
Wetland WB-3 – Wetland WB-3 was 0.04 acres in size, located within a depression in an undeveloped forest patch in the northwestern corner of the Project Area. The source of wetland hydrology was primarily surface runoff. Dominant vegetation included black currant (*Ribes americanum*) in the shrub layer and small-flowered agrimony and cinnamon fern (*Osmundastrum cinnamomeum*) in the herb layer. Hydric soil conditions met the requirements of a depleted matrix starting at 0 inches and continued for 8 inches. A hydrogen sulfide odor was also observed. This wetland was isolated with no apparent hydrologic connection to a WOTUS and therefore it should not be afforded jurisdiction from USACE. Since it was less than 12.4 acres in size and was not the current boundary of a mapped NYSDEC Freshwater Wetland, it should not be under State jurisdiction.

Photograph 15 – Wetland WB-3
Facing north.
[Taken by Tony Cimpi on May 3, 2021]

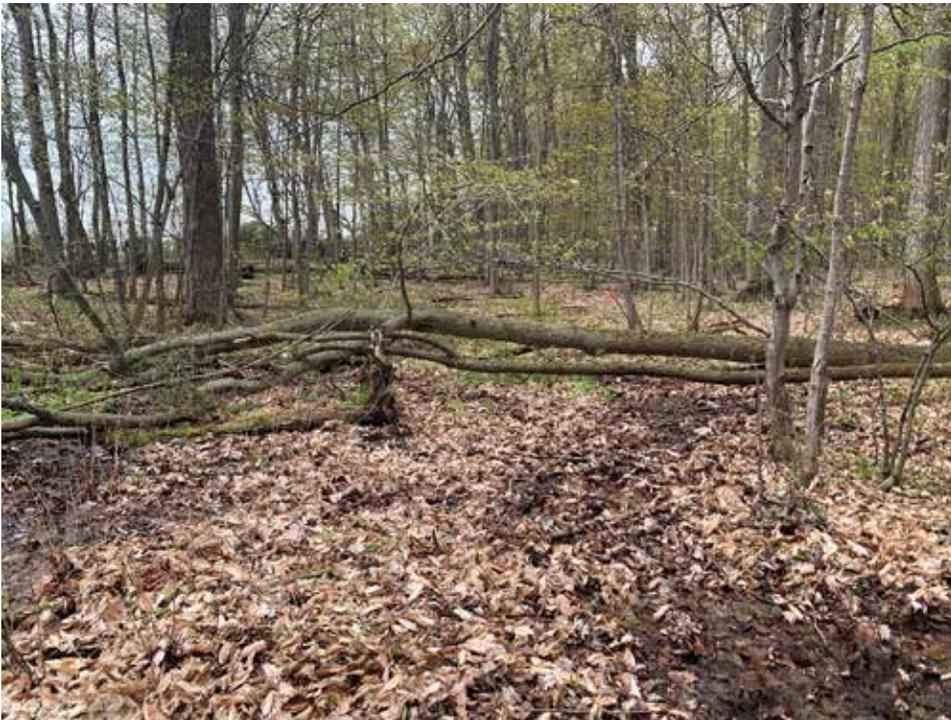
Wetland WB-4 – Wetland WB-4 was 0.05 acres in size, located within a depression in an undeveloped forest patch in the northwestern corner of the Project Area. The source of wetland hydrology was primarily drainage from an ephemeral stream (SB-1) and a high-water table. Dominant vegetation included black currant in the shrub layer and jewelweed in the herb layer. Hydric soil conditions met the requirements of redox dark surface starting at 0 inches and continued for 20 inches. This wetland was isolated with no apparent hydrologic connection to a WOTUS and therefore it should not be afforded jurisdiction from USACE. Since it was less than 12.4 acres in size and was not the current boundary of a mapped NYSDEC Freshwater Wetland, it should not be under State jurisdiction.

Photograph 16 – Wetland WB-4
Facing south.
[Taken by Tony Cimpi on May 3, 2021]

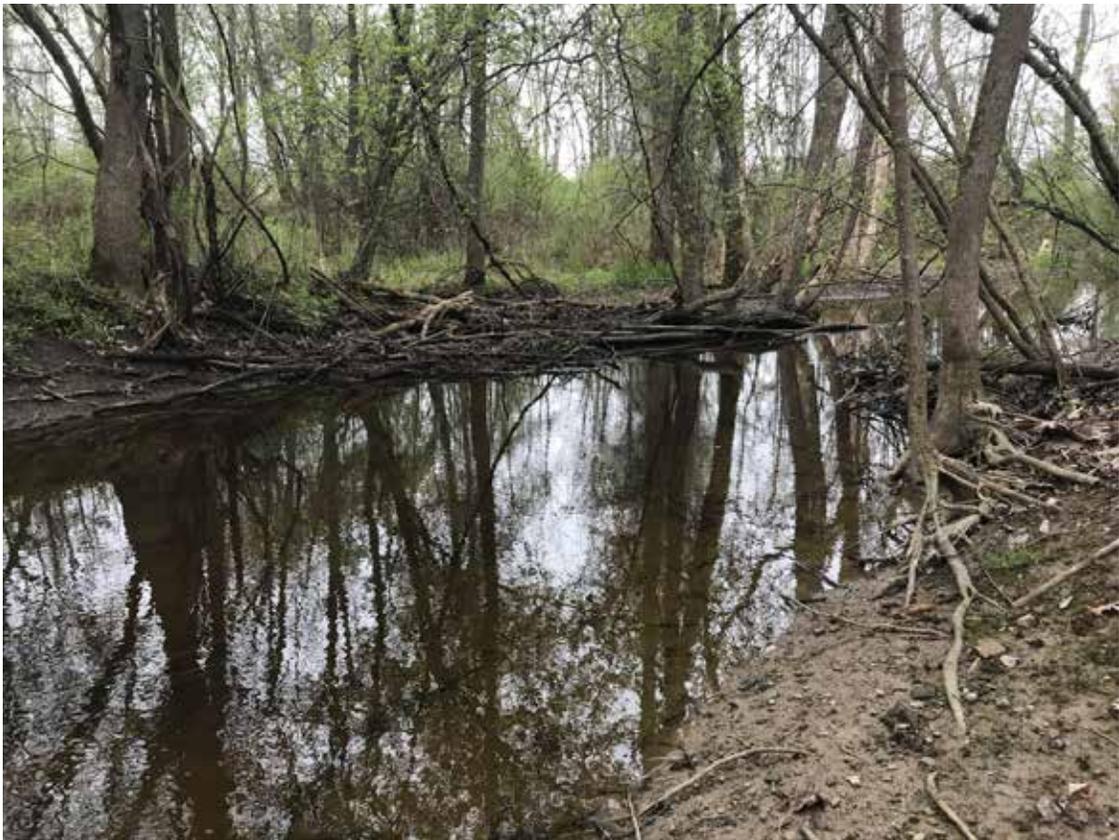
Photograph 40 – Stream SA-2
Showing eastern portion of Fish Creek in the main parcel. Facing north.
[Taken by Jessica Atutubo on May 4, 2021]

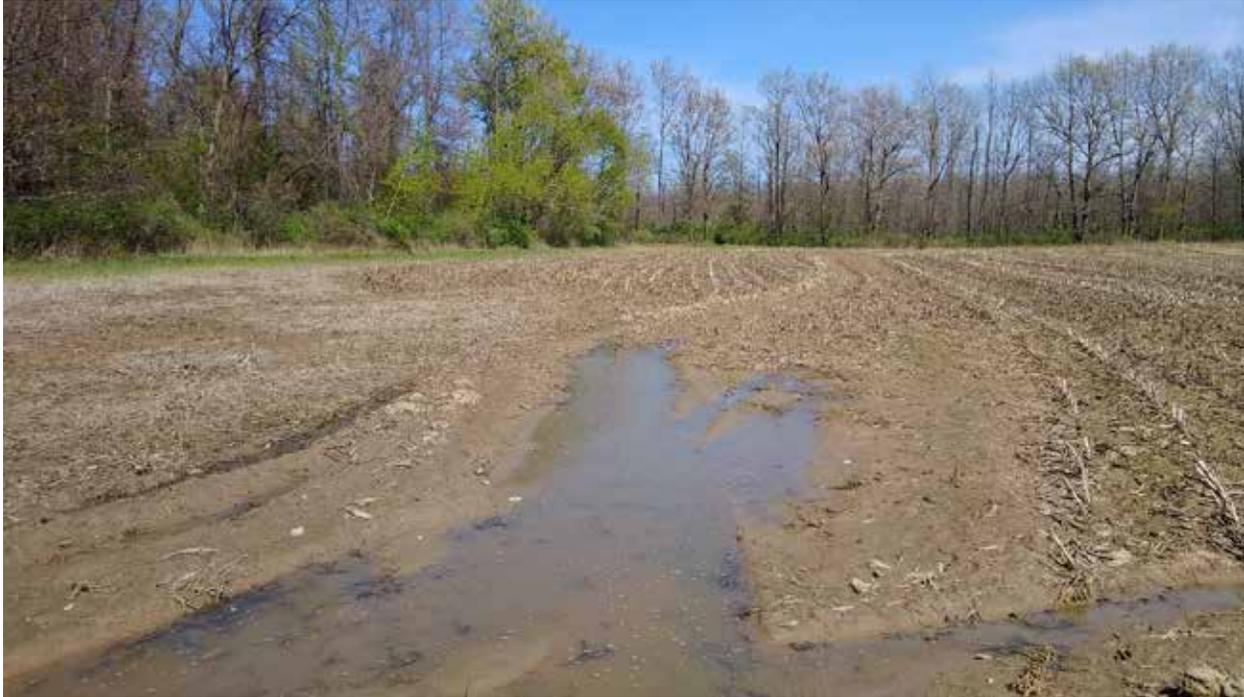
Photograph 45 – Stream SA-7

Showing stream connecting to forested wetland (WA-12) in background. Facing east.
[Taken by Drew Timmis on May 6, 2021]

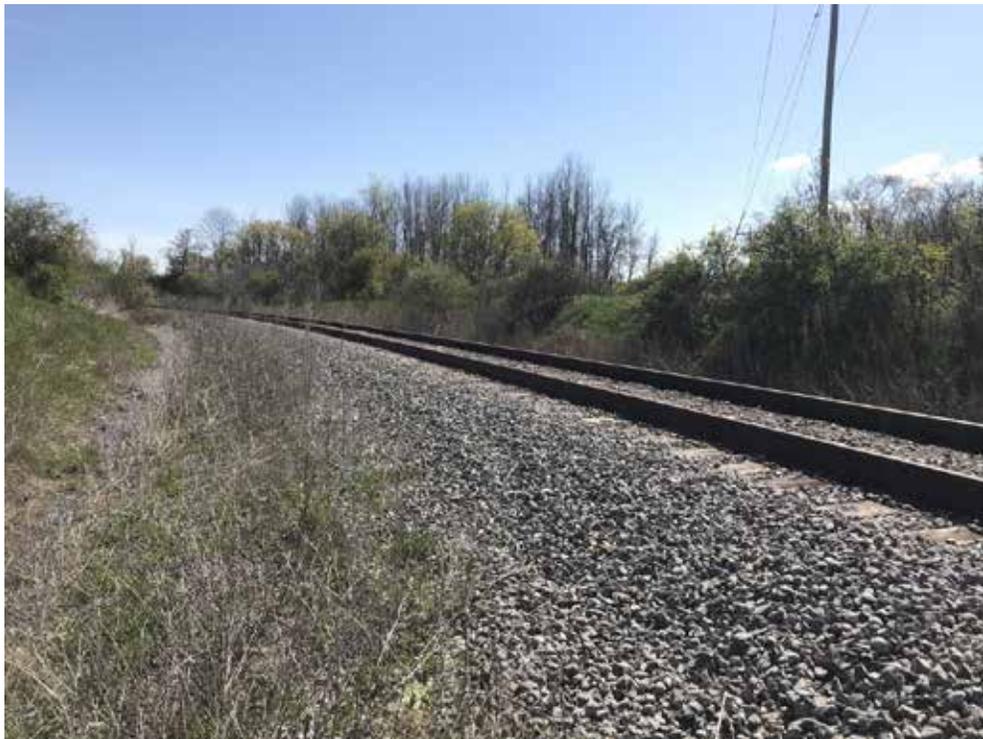
Photograph 46 – Stream SA-8

Showing feature on left side of photo along railroad tracks. Facing east.
[Taken by Jessica Atutubo on May 10, 2021]

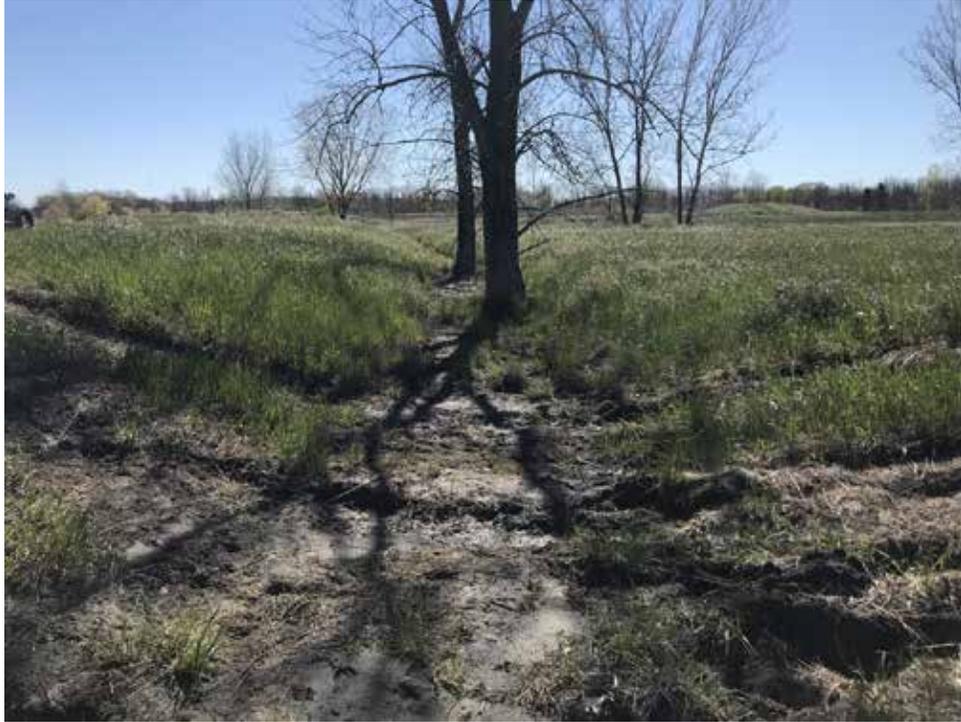
Photograph 51 – Stream SA-13
Facing east southeast.
[Taken by Jessica Atutubo on May 12, 2021]

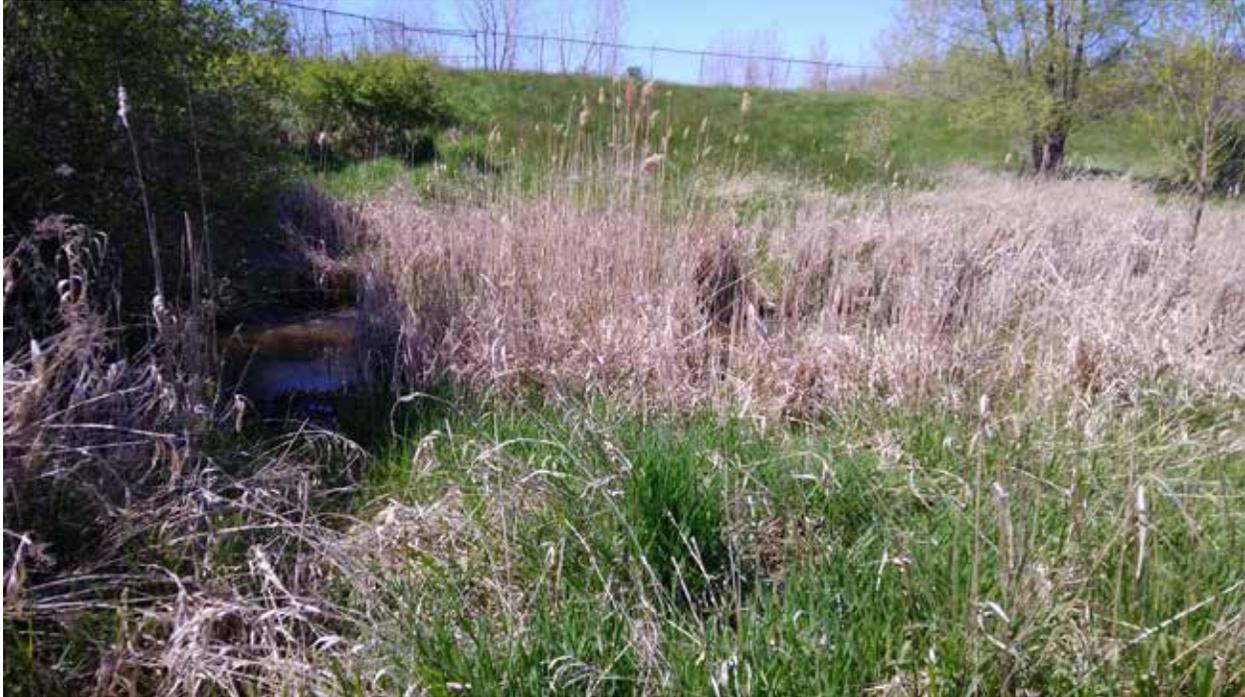
Photograph 53 – Stream SA-15
Showing *Phragmites* on banks stream.
[Taken by Drew Timmis on May 12, 2021]

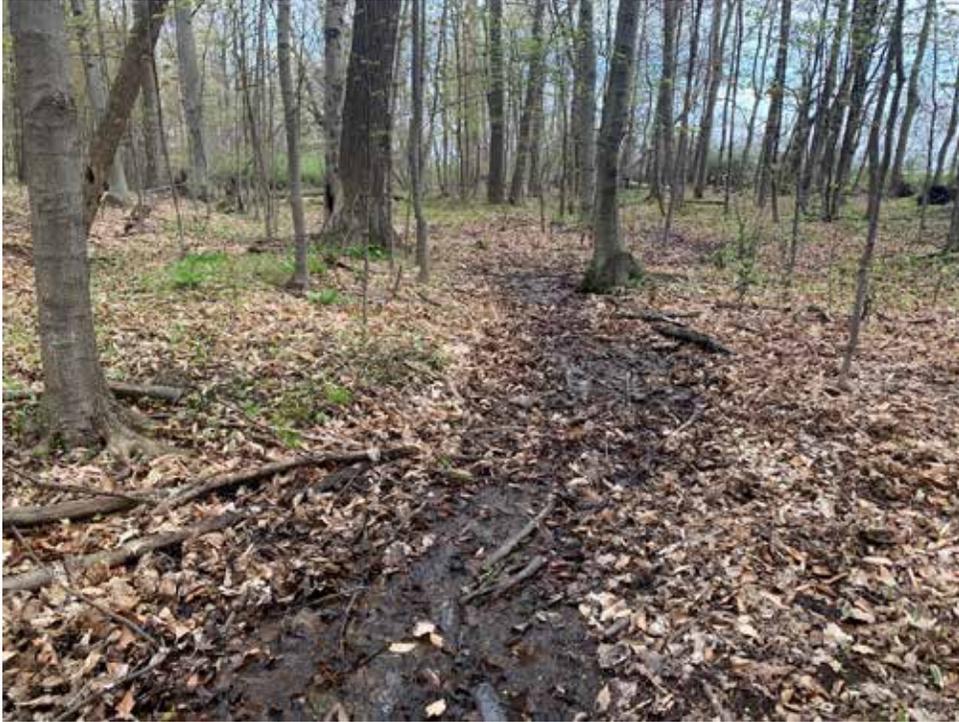
Photograph 59 – Stream SB-1
Showing downstream view.
[Taken by Tony Cimpi on May 3, 2021]

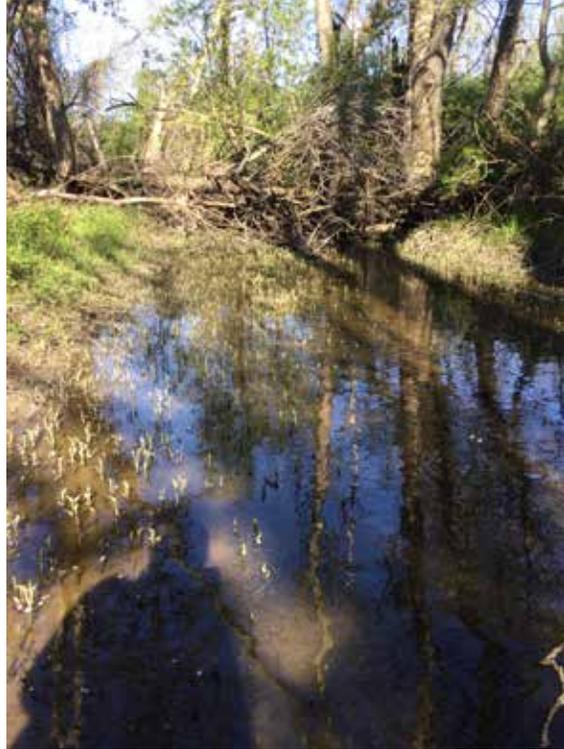
Photograph 61 – Stream SB-3

View of central portion of Fish Creek within main parcel.
[Taken by Tony Cimpi on May 12, 2021]

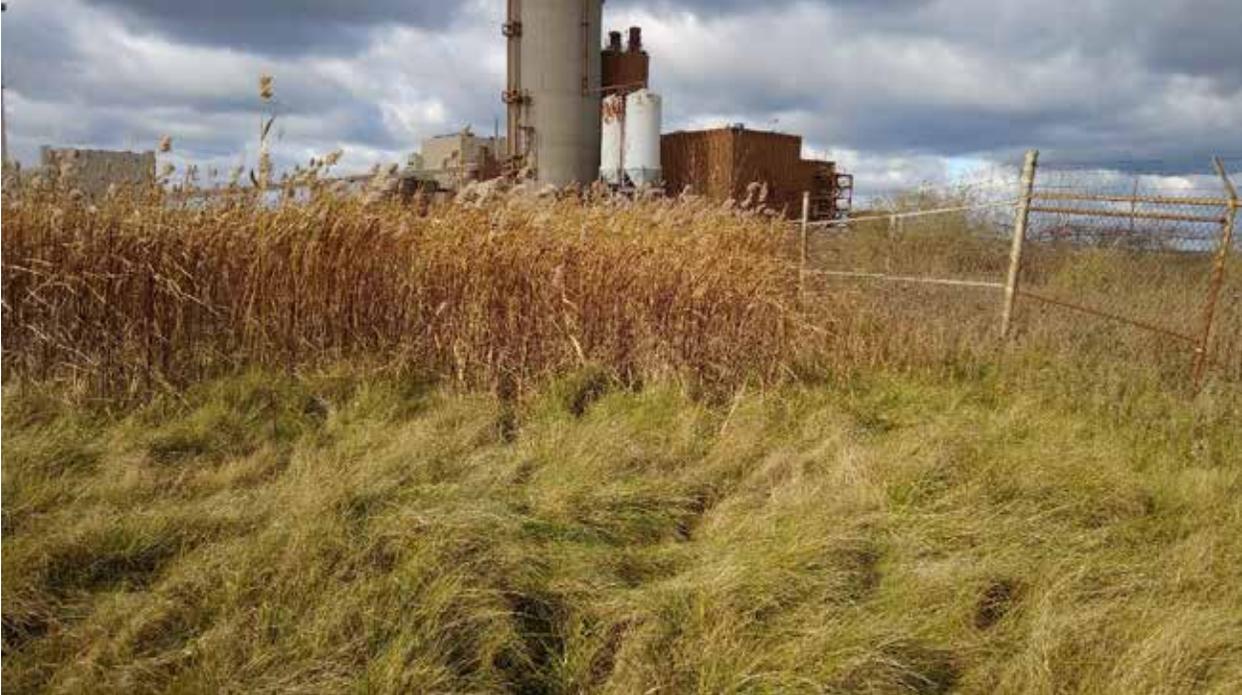
Photograph 1 – Wetland WA-200
Facing west, emergent wetland continues to the north along drainage ditch.
[Taken by Drew Timmis on November 22, 2021]

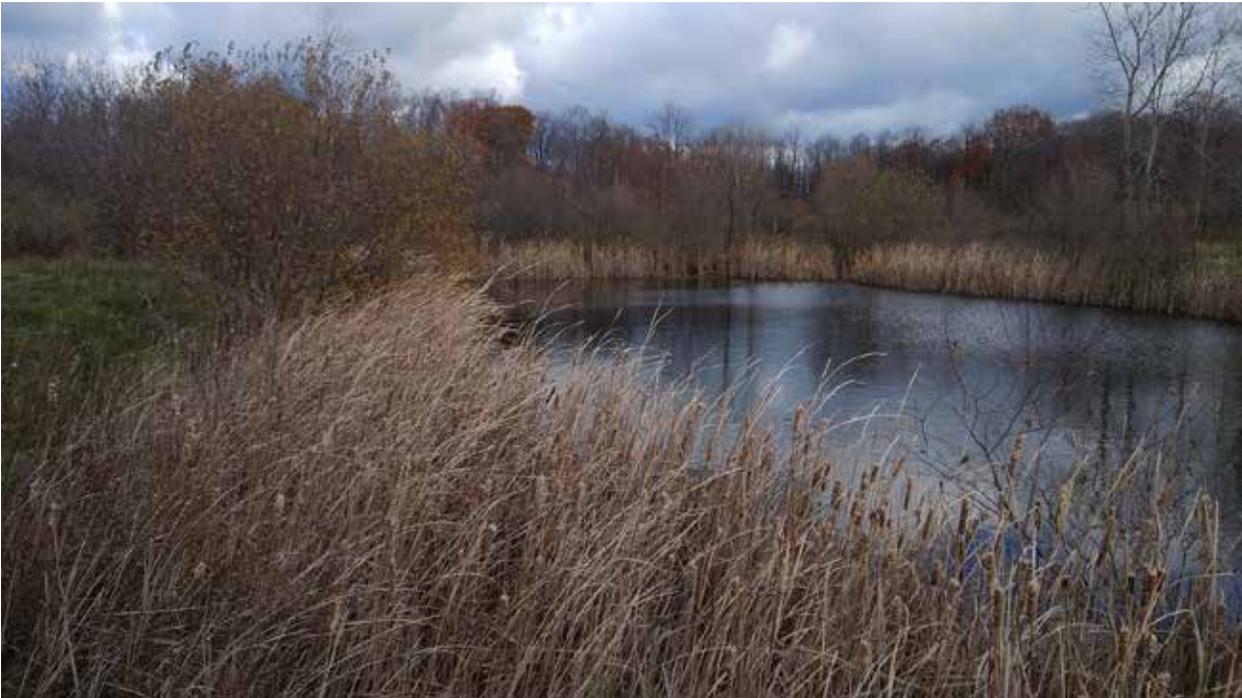
Photograph 2 – Pond OW-200
View of manmade retention pond facing northeast.
[Taken by Drew Timmis on November 22, 2021]
