# **Historic Architectural Resources Survey and Effects Report**

Riverside Solar Energy Project  
Towns of Lyme and Brownville,  
Jefferson County, New York

**SHPO Project Review Number:  
20PR03909**

May 2021

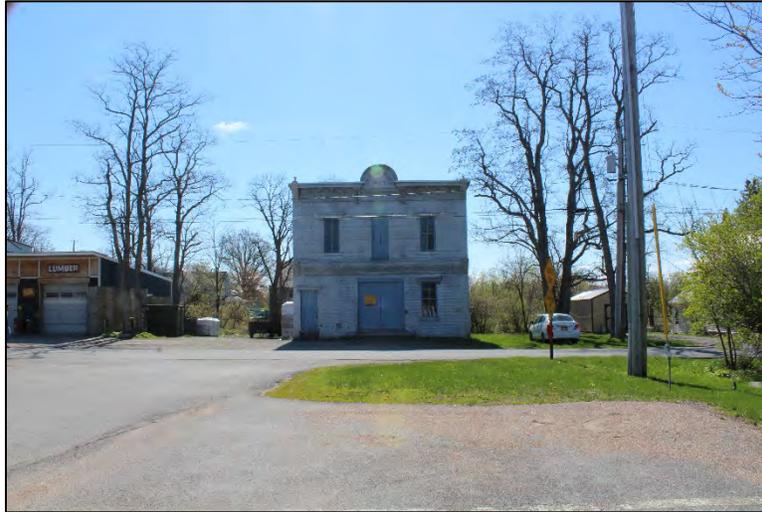
### 6.1.1 George Brothers Building, 27488 Mill Street, Chaumont

View northeast toward Project Area. Photograph taken from the northwest side of Mill Street, opposite 27488 Mill Street

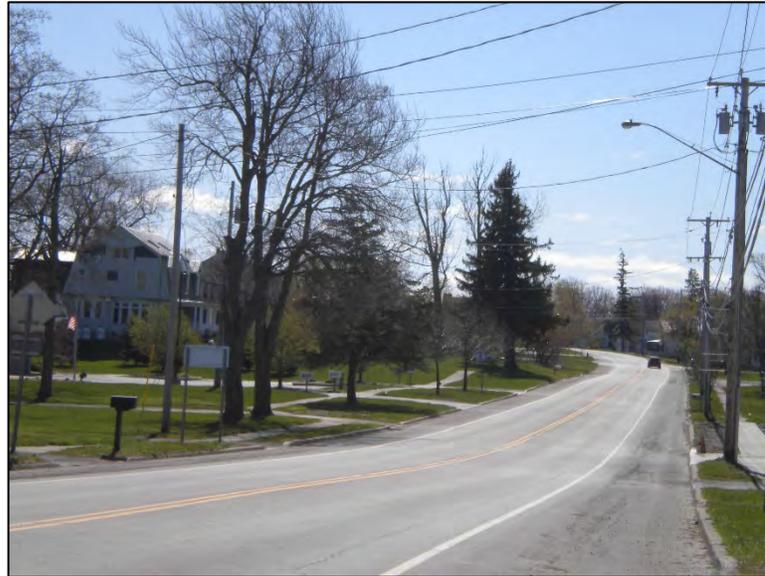
**6.1.2 Chaumont Grange and Dairymen’s League Building, 12166 Main Street, Chaumont**

*View northeast toward Project Area. Photograph taken looking northeast down Main Street from resource.*

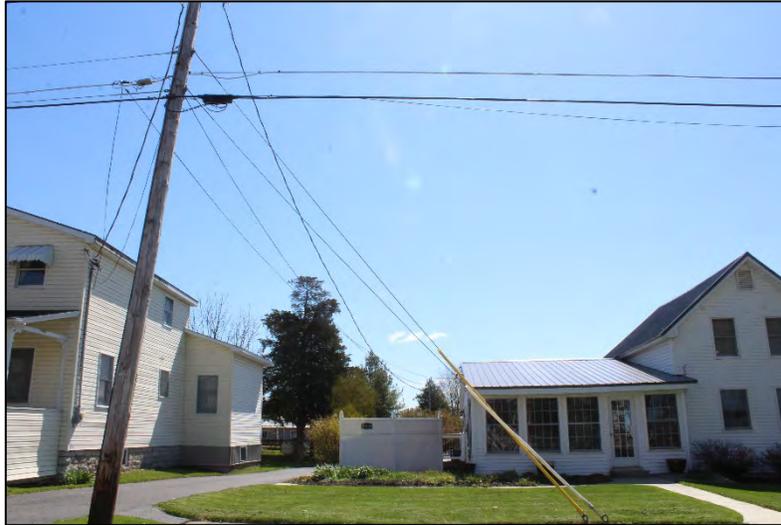
### 6.1.3 George House, 27405 Washington Street, Chaumont

View northeast toward Project Area. Photograph taken from the northwest side of Washington Street, opposite 27405 Washington Street

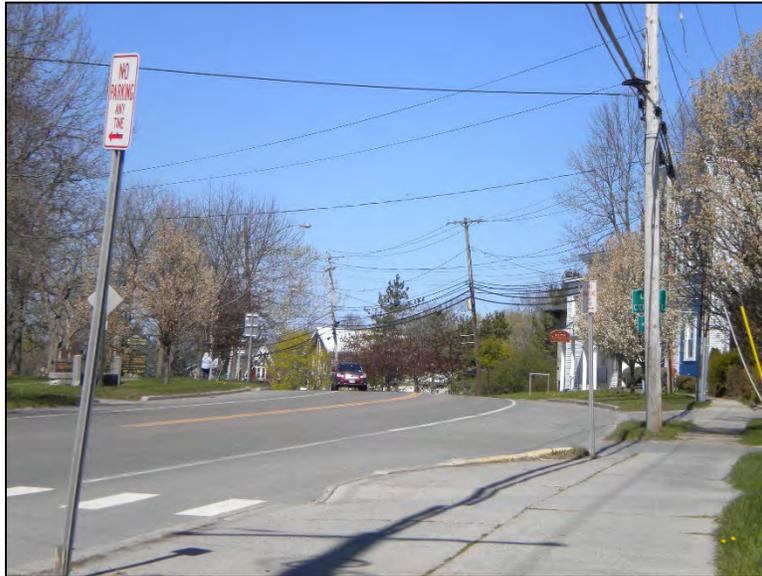
### 6.1.4 Chaumont Historic District, various addresses, Chaumont

*View northeast toward Project Area from Main Street.*

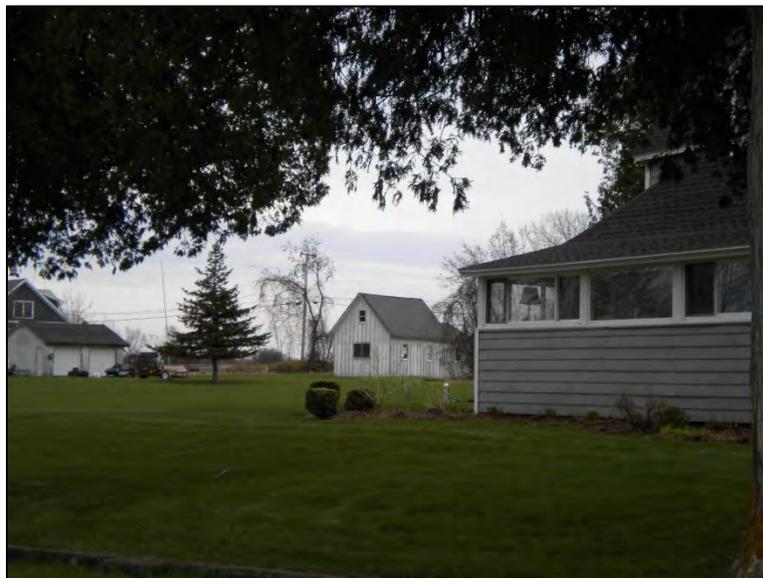
**6.1.5 Point Salubrious Historic District, various addresses, Lyme**

*View northeast along County Road 125 looking toward Project Area.*

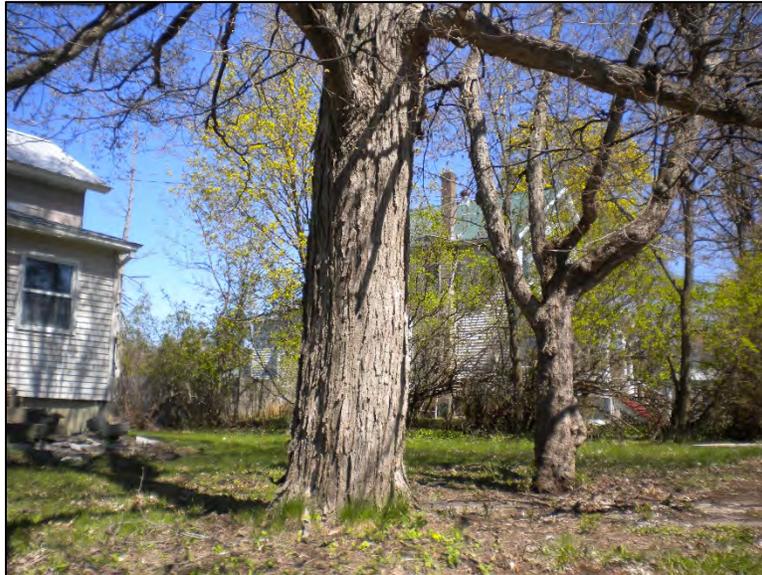
### 6.1.6 House, 27375 Washington Street, Chaumont

*View looking north toward Project Area from sidewalk in front of 27375 Washington Street.*

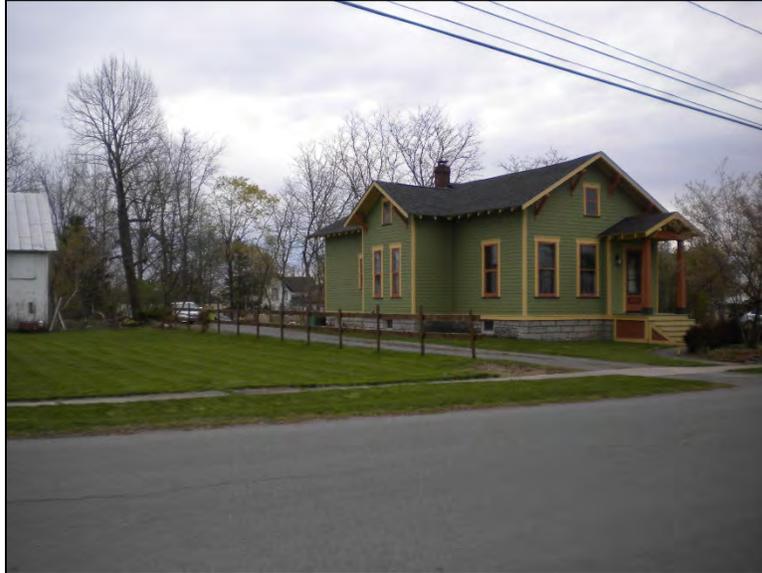
### 6.1.7 House, 27490 Washington Street, Chaumont

View northeast toward Project Area. Photograph taken from the northwest side of Washington Street, opposite 27490 Washington Street.

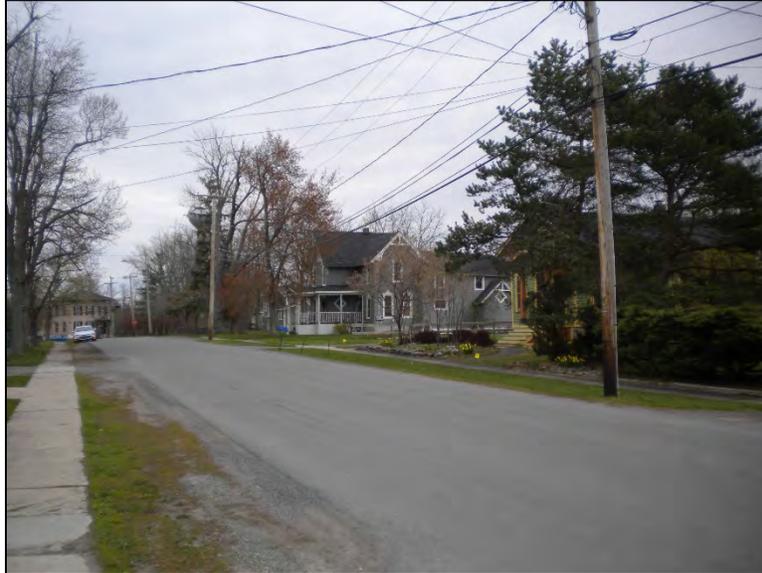
### 6.1.8 Saint Paul's ME Church, 27487 Washington Street, Chaumont

View north along Washington Street from the historic property toward Project Area.

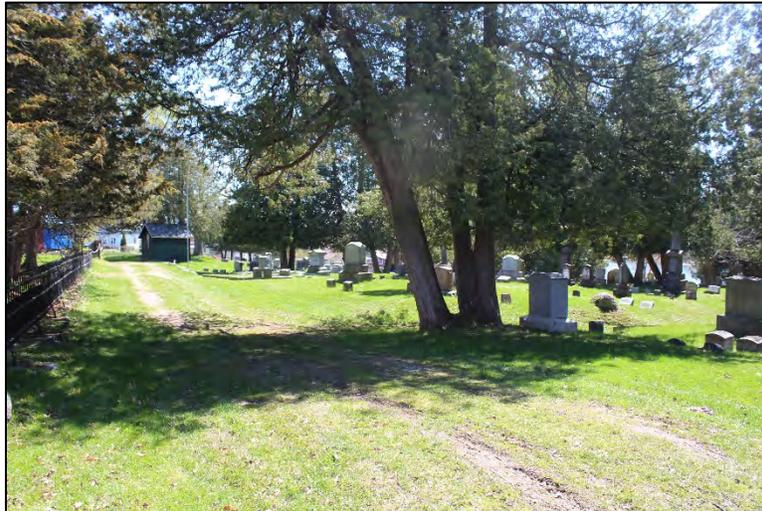
### 6.1.9 Cedar Grove Cemetery, Washington Street, Chaumont

*View from within Cedar Grove Cemetery looking northeast toward Project Area.*

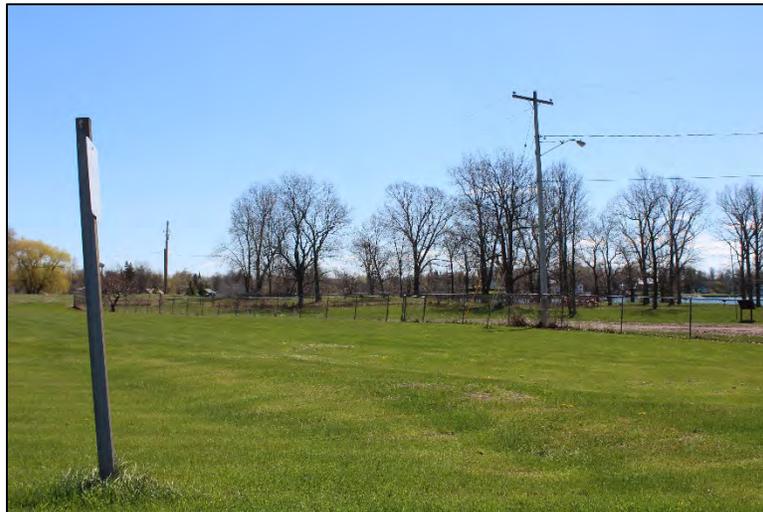
### 6.1.10 Cemetery, Wilson Lane, Chaumont

*View from within the cemetery looking northeast toward Project Area.*

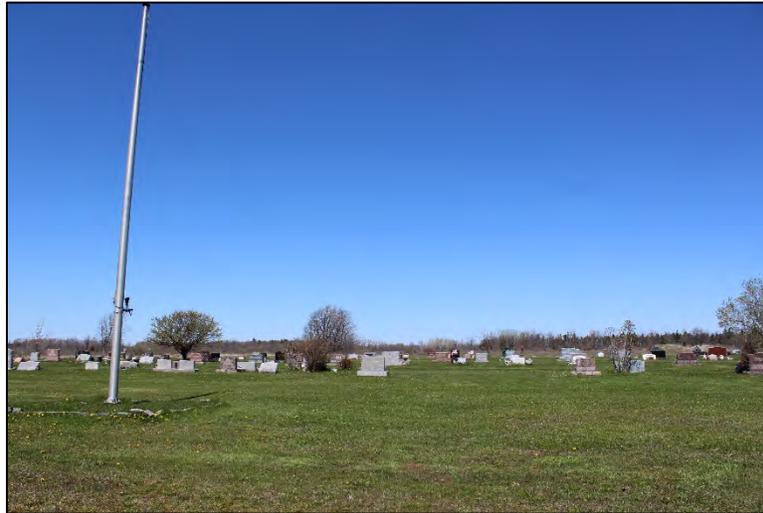
### 6.1.11 New Cedar Grove Cemetery, NY 12E, Lyme

*View from within New Cedar Grove Cemetery looking north toward Project Area.*

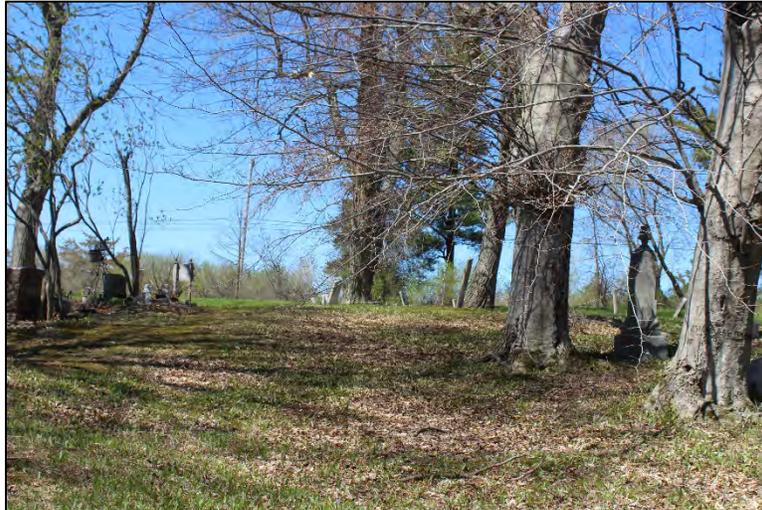
### 6.1.12 Freeman Cemetery, Morris Tract Road, Brownville

*View from within Freeman Cemetery looking north toward Project Area.*

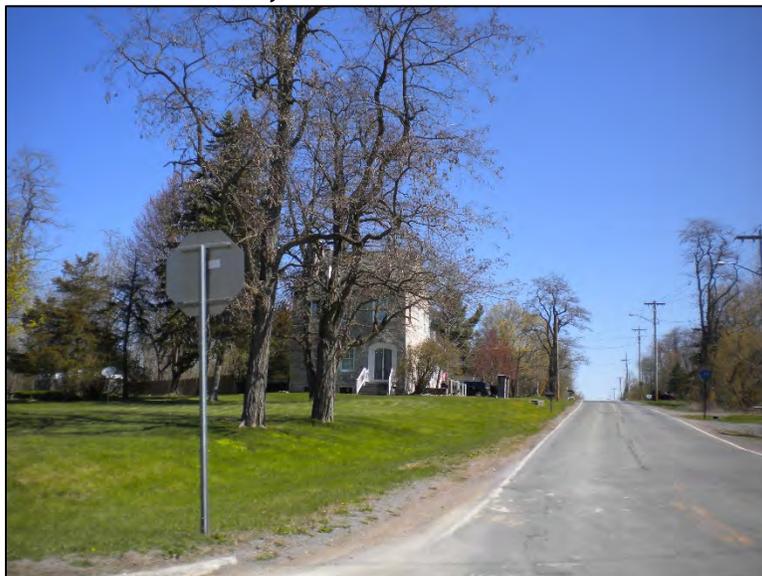
### 6.1.13 House, 27655 Evans Street, Chaumont

*View looking north toward Project Area. Photograph taken at the intersection of Evans and Main streets, looking north 27655 Evans Street.*

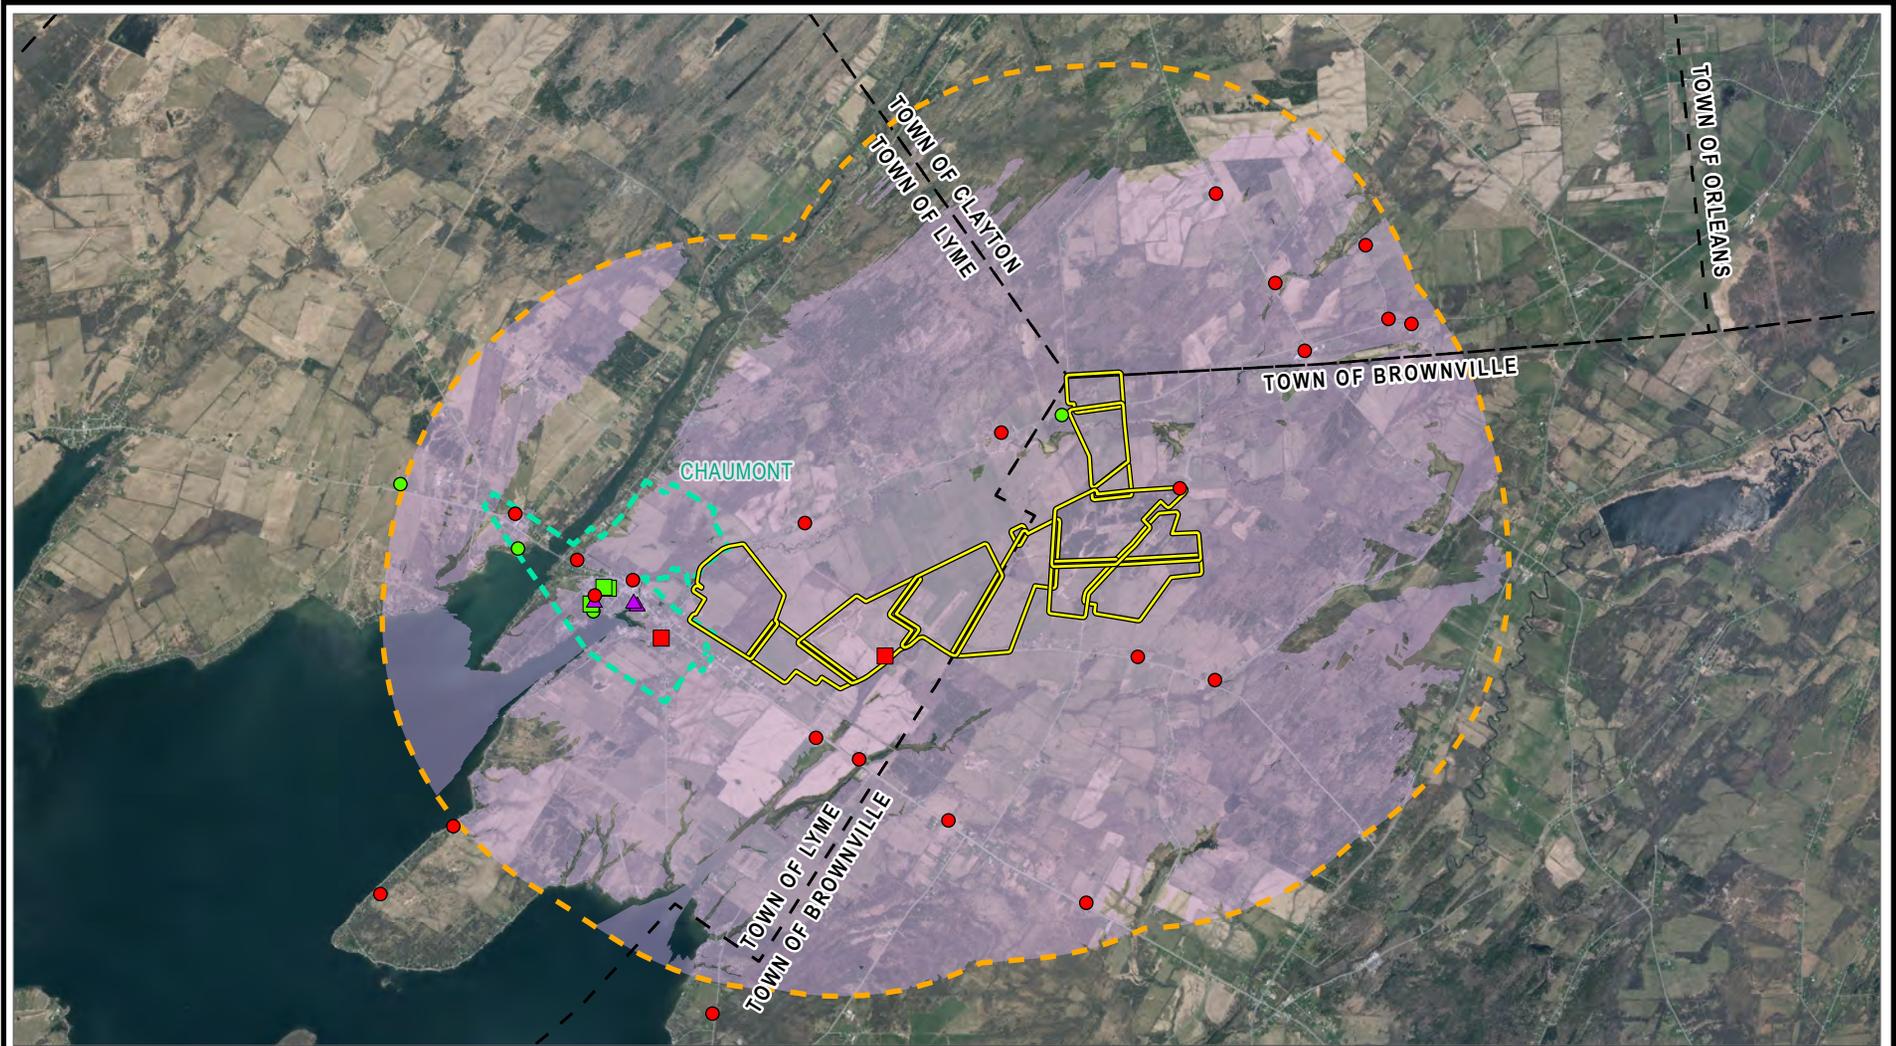
PROJECT: <b>RIVERSIDE SOLAR LLC TOWNS OF LYME &amp; BROWNVILLE JEFFERSON COUNTY, NY</b>	
TITLE: <b>ARCHITECTURAL RESOURCES SURVEY RESULTS</b>	
DRAWN BY: D. STITCHER	PROJ. NO.: 373222.0000.0000
CHECKED BY: G. STUDWELL	<b>FIGURE 3</b>
APPROVED BY: NAME	
DATE: MAY 2021

Table 3 provides the results of the field survey and a summary of TRC's eligibility recommendations. All previously surveyed resources are indicated as such with their USN. Figure 3 in Attachment A is a map of all surveyed resources in the ZVI.

PROJECT AREA	<b>ARCHITECTURAL SURVEY RESULTS</b>
2 MILE STUDY AREA	NEWLY SURVEYED, NOT ELIGIBLE
TOWN BOUNDARY	NEWLY SURVEYED, RECOMMENDED ELIGIBLE
VILLAGE BOUNDARY	PREVIOUSLY SURVEYED, ELIGIBLE
ZONE OF VISUAL IMPACT (ZVI)	PREVIOUSLY SURVEYED, NOT ELIGIBLE
	PREVIOUSLY SURVEYED, LISTED
